Isdammen report 2009

AT- 205

Frozen Ground Engineering for Arctic Infrastructure

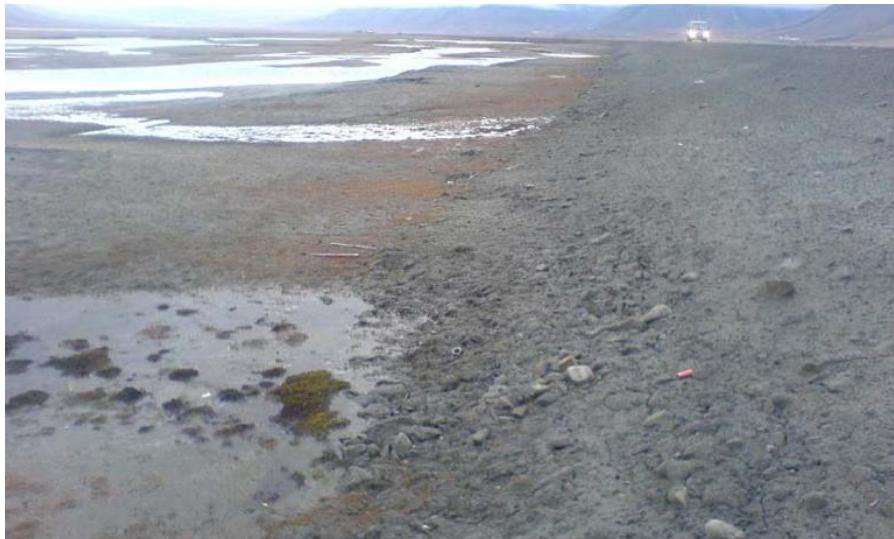
The leakage of the dam could be a problem for the future if new different points of leakage will be created. It will increase the leakage discharge and may cause a negative water balance. In the water balance studies you have to take into account the spring snow storage, the areal

Figure 5: One point of leakage of Isdammen water reservoirs [NGI report]

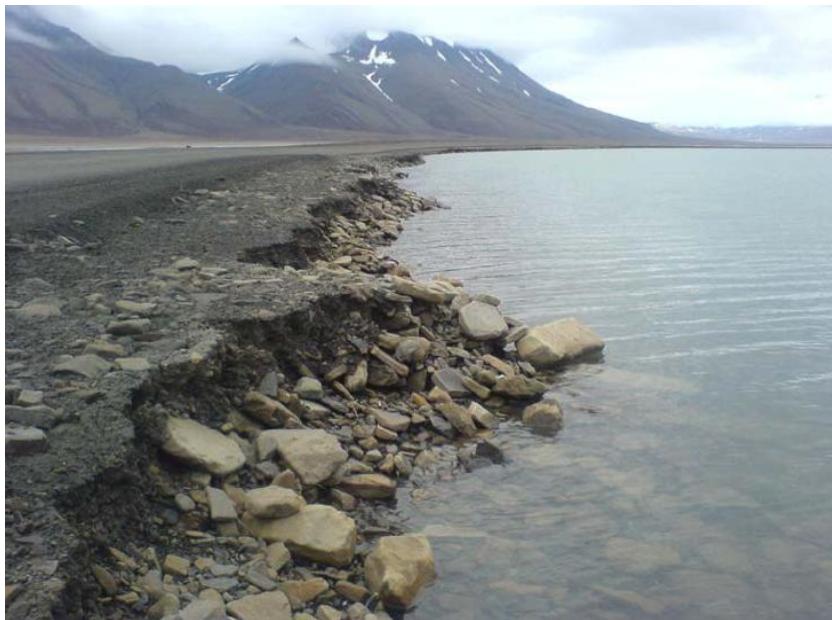
Different erosion processes are present on Isdammen, the main processes are erosion by the snowmelt runoff, rainflood during the summer and wind that cause waves.

Figure 7: Erosion process, erosion caused by waves coming from frequent winds [1]

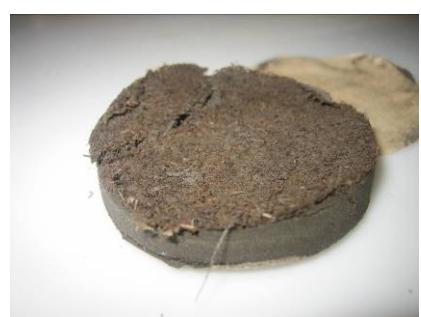
As mentioned in our labreport it was found a layer in the samples from Nordlysstasjonen containing considerable amounts of organic material. This layer was present from 2.48 to 2.70 meters. Due to topography and geological history it can be assumed a presence of a similar layer under Isdammen. The layer is assumed to be deeper then the depth we reached during drilling. We can assume that this potential layer is at least four meters under the top of Isdammen. Organic layers have a high

**Figure 9: Orangic material found at Nordlysstasjonen**

permeability, are frost susceptible and are a very soft material. If this layer exists it can be one of the explanations of the leaking and frost related damages to the dam.

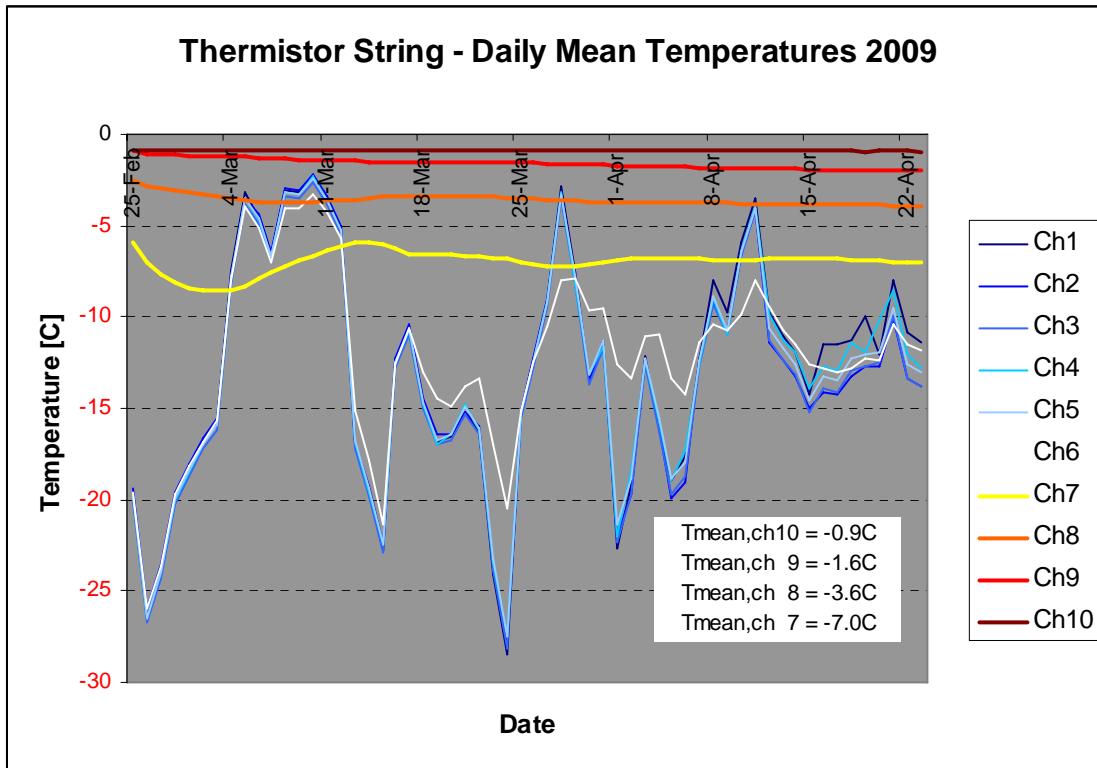
**Figure 13: Daily mean values of air and ground temperatures in bore hole at road embankment of Isdammen. Thermistor channels 1-5 is located approximately 0,5m above ground surface, channel 6 approximately at ground surface and channels 7-10 gradually downwards to bottom of the bore hole at 4.8m**

Channels 1-5 represents air temperatures as those thermistors are coiled up in the top of the access tube 0.5m above ground level, and responds closely to solar radiation after about mid Mars. This effect is not that obvious in Figure 13 because the curves are averaged daily values. Channel 6 is not responding in the same way to solar radiation and is therefore assumed to be at or slightly above ground surface level.

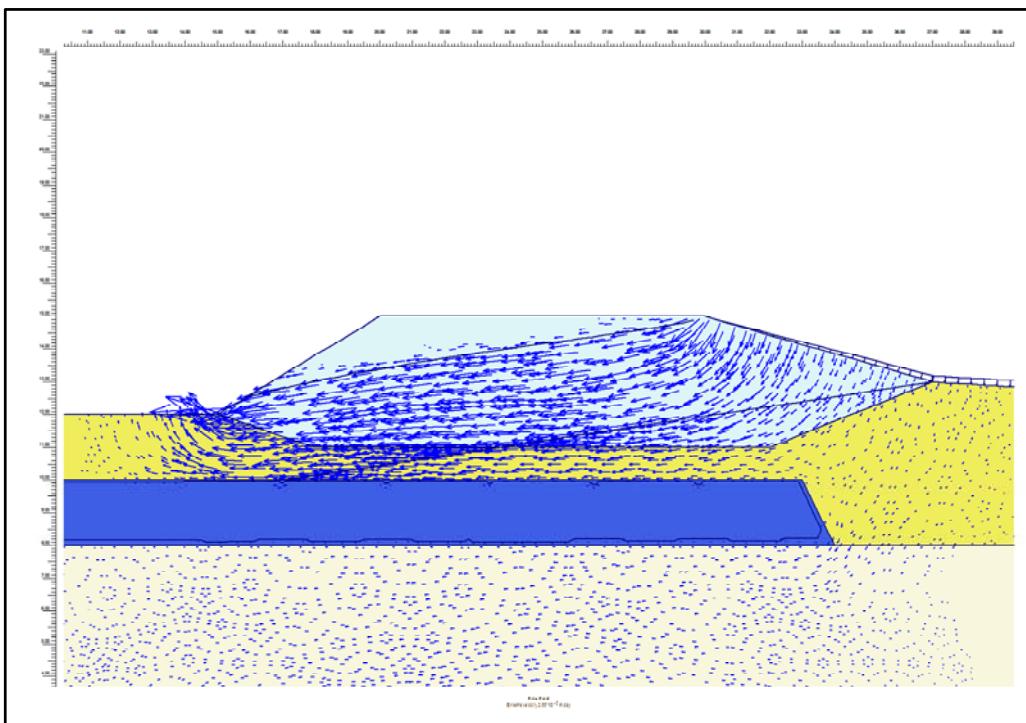
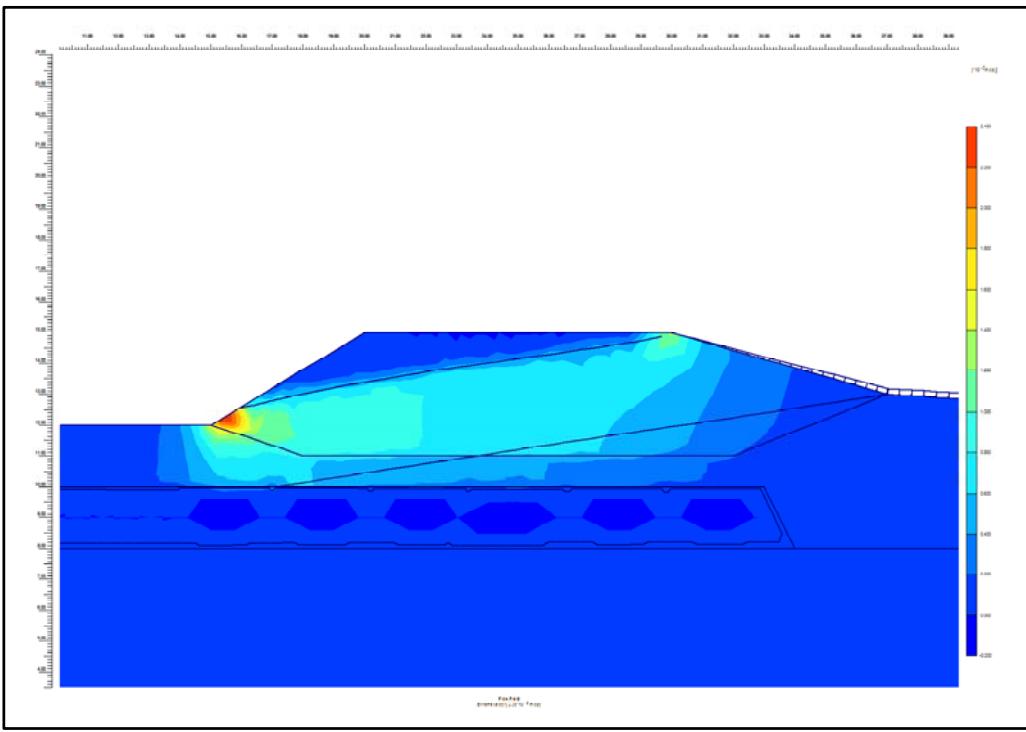
**Figure 18: Flow field, extreme velocity  $2,55e-3$ .**

**Figure 19: Flow field in shadings**

These figures represent water flow during summer period. The flow starts from the lake's bed. It goes under the road at the depth of 2-4 m and comes from the bottom part of the dam. Where the flow has the maximum velocity,  $2.5\text{e}-03$  m/day. This process causes corrosion of the soils. On the next Figure we can see deformations.

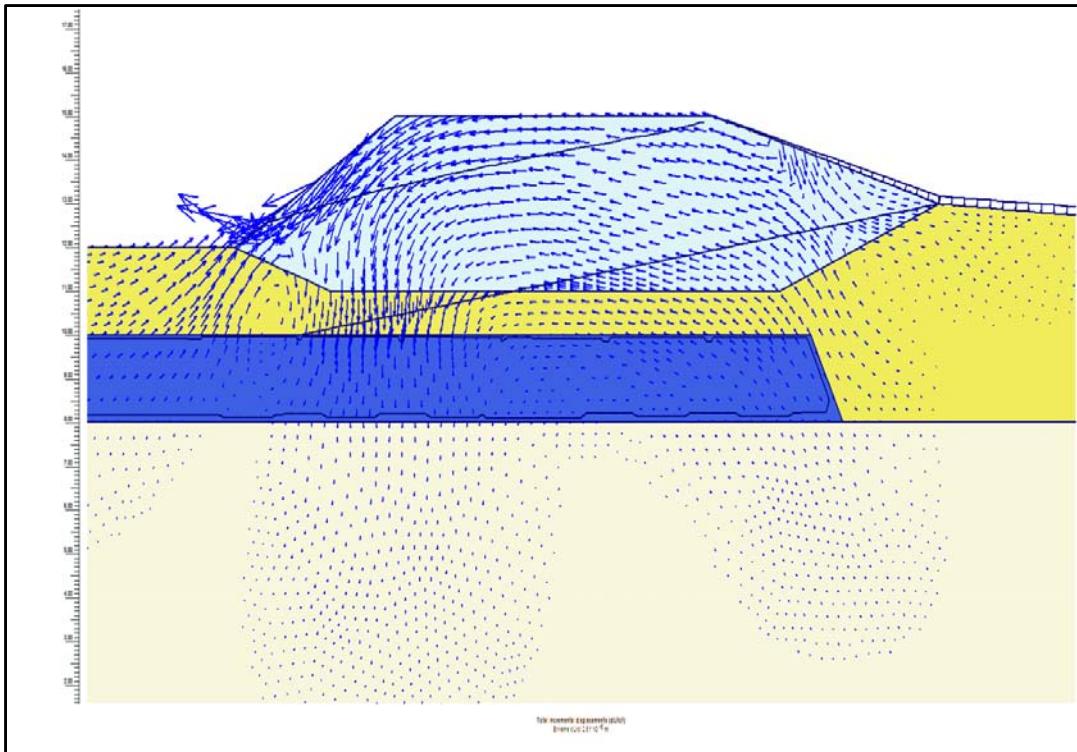
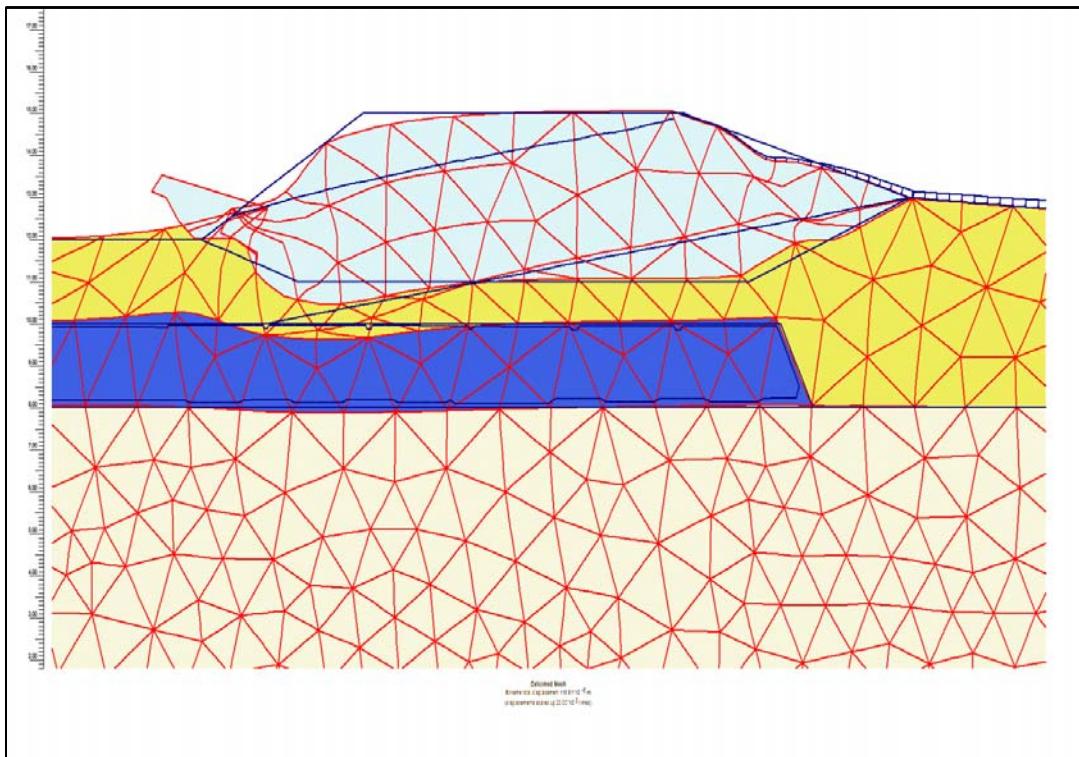
**Figure 20: Total increments of deformations**

**Figure 21: Deformed mesh (Scaled up 20e+03).**

The top part of the dam starts to slide down. Also there is deformation process of the lake bed, erosion of the soils. This process isn't very large (maximum deformation is 2,5e-06). Anyway it has effects on the road pavement.

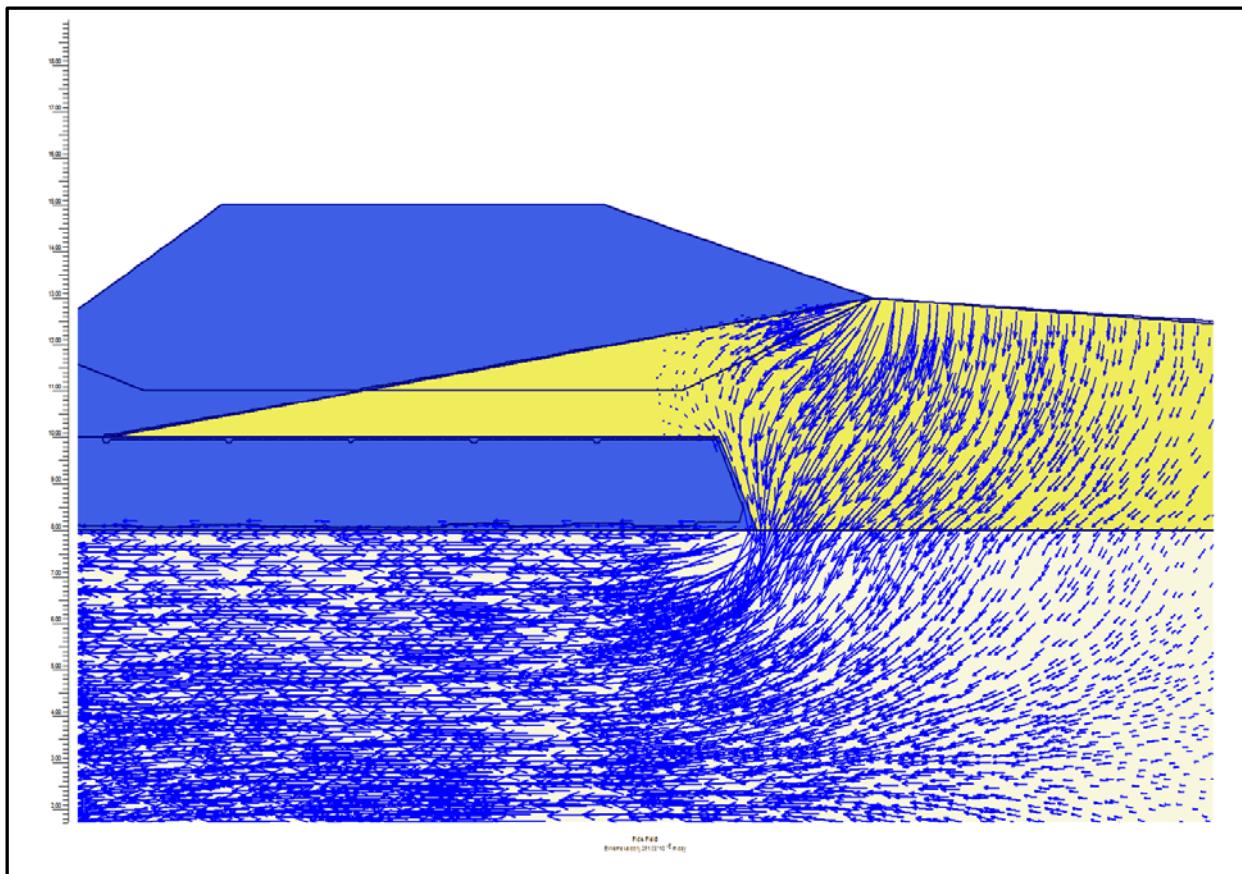
**Figure 22: Flow field during winter**

During winter water level undergoes deeper, also large portion of soils is frozen. So water flows downwards or underneath the lake. The velocities are quite small (the maximum is 250e-06 m/day). During this period there's no big damage to the dam due to the properties of permafrost.

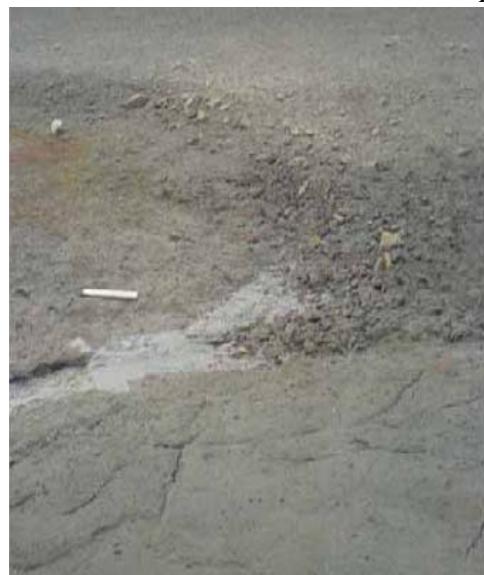
Isdammen have probably always had leakage [1].

Figure 24: Leaking point [1]

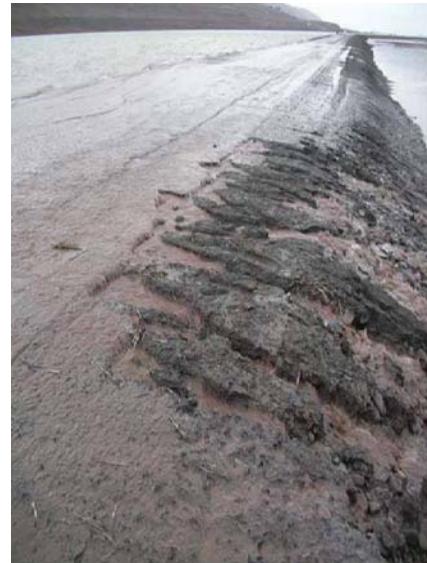
The material in the dam, as mention before, has high silt content. Silt is a frost acceptable material, and the dam can be affected by frost heave in the active layer under it. This may result in a reorganization of the grains, which can increase the leakage.

**Figure 25: Water washing over the road [1]**
