Sukkertoppen Svalbard - avalanche incidents

DOCUMENTATION OF AVALANCHES

DOC.NO. 20171006-01-R REV.NO. 0 / 2017-12-11

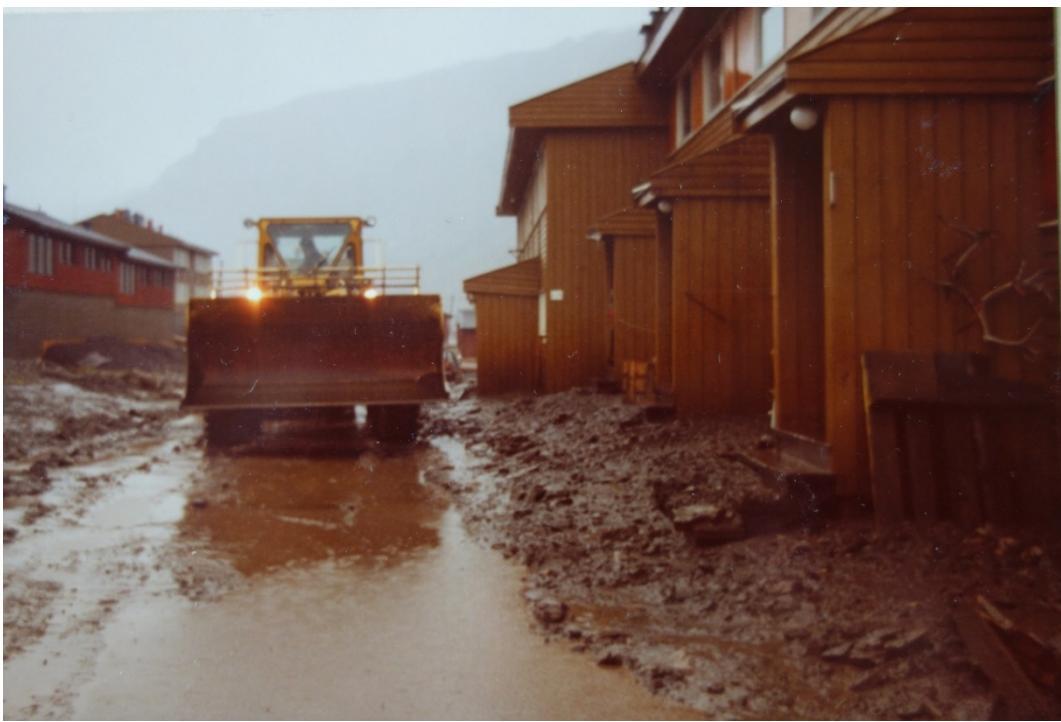
The buildings in road 228 (6-16) and 228 (7-11) were hit by a debris flow 5th August 1981 in a situation where the airport got 55 mm rain in 30 hours (NGI, 1992). Photos 2.1-2.2 show the event. Parts of building 228 (6-16) was damaged, and debris filled up most of the ground floor of flat 228/12. The debris flow continued further down road 228.

Photo 2.1: Debris flow in August 1981 causing damage on buildings in road 228 (6-16). Photo: Turid Telebond.

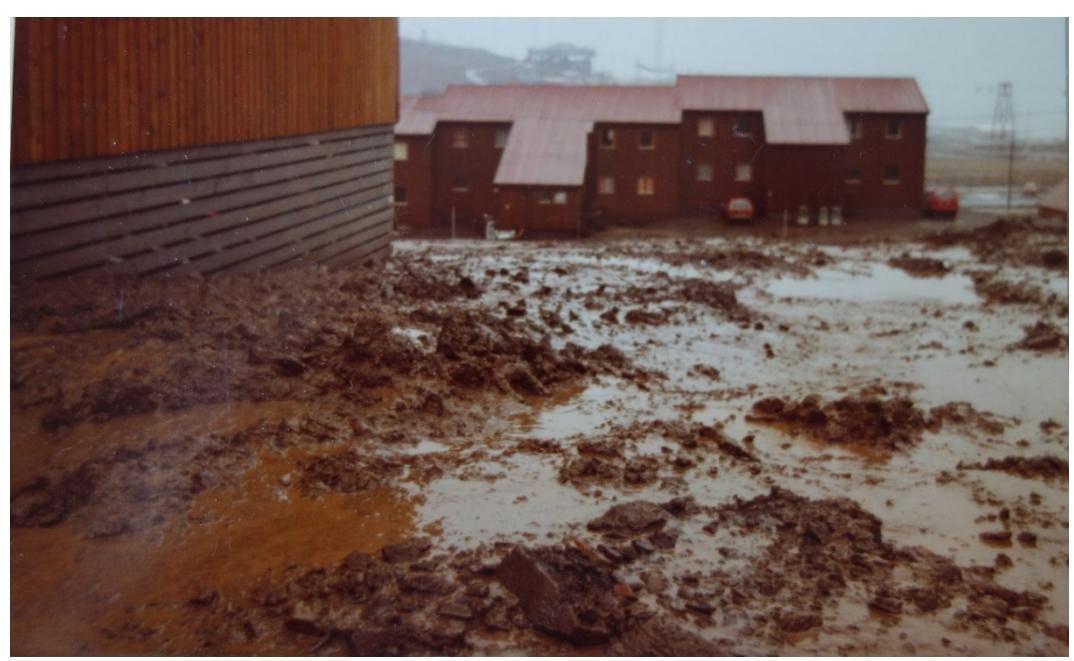
Photo 2.2: Debris flow in August 1981. To the left 228 (6) and below 228 (7-11). Photo: Turid Telebond.

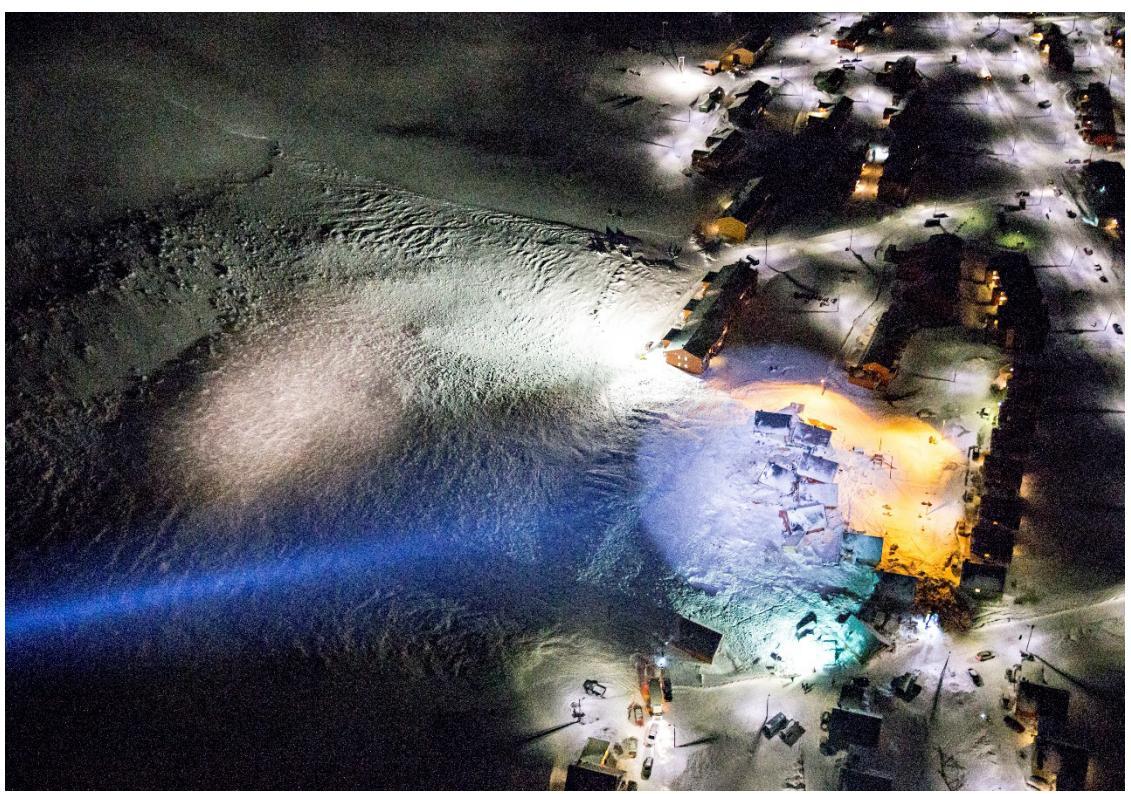
The avalanche crown was about 175 m long situated 130-110 masl. The avalanche hit the upper row of houses in road 230 situated about 40 masl, and stopped at the third row of houses about 33 masl. The part of the avalanche with the longest runout stopping at house 230/2 had about 80 m vertical drop.

Photo 5.1.1: Picture a few days after the avalanche. Photo: Christopher Engås.

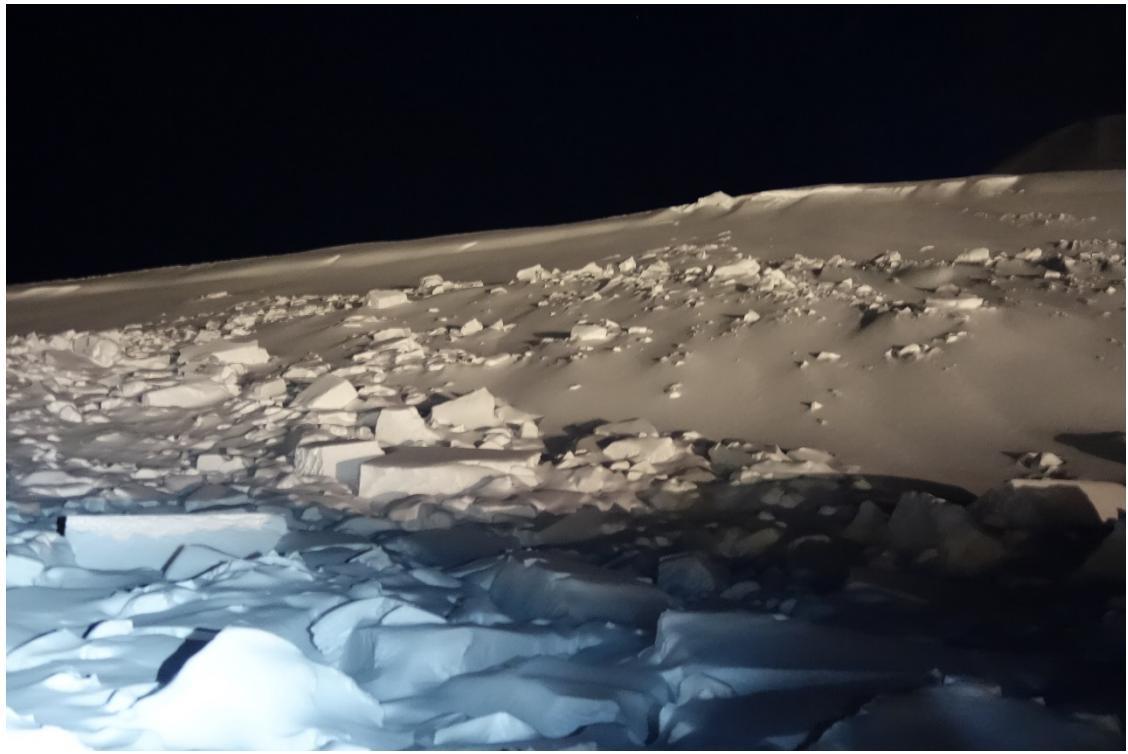
The thickness of the avalanche is not known. NGI invested the crown face 1 day after the accident when it had been substantial snowdrift after the release. NGI measured crown height (vertically) from 1m to 2, 5 m. The flank on the left part (seen upwards) was 3-4 m high.

Photo 5.2.5: Crown and debris 1 day after the avalanche released. Photo: Kjetil Brattlien.

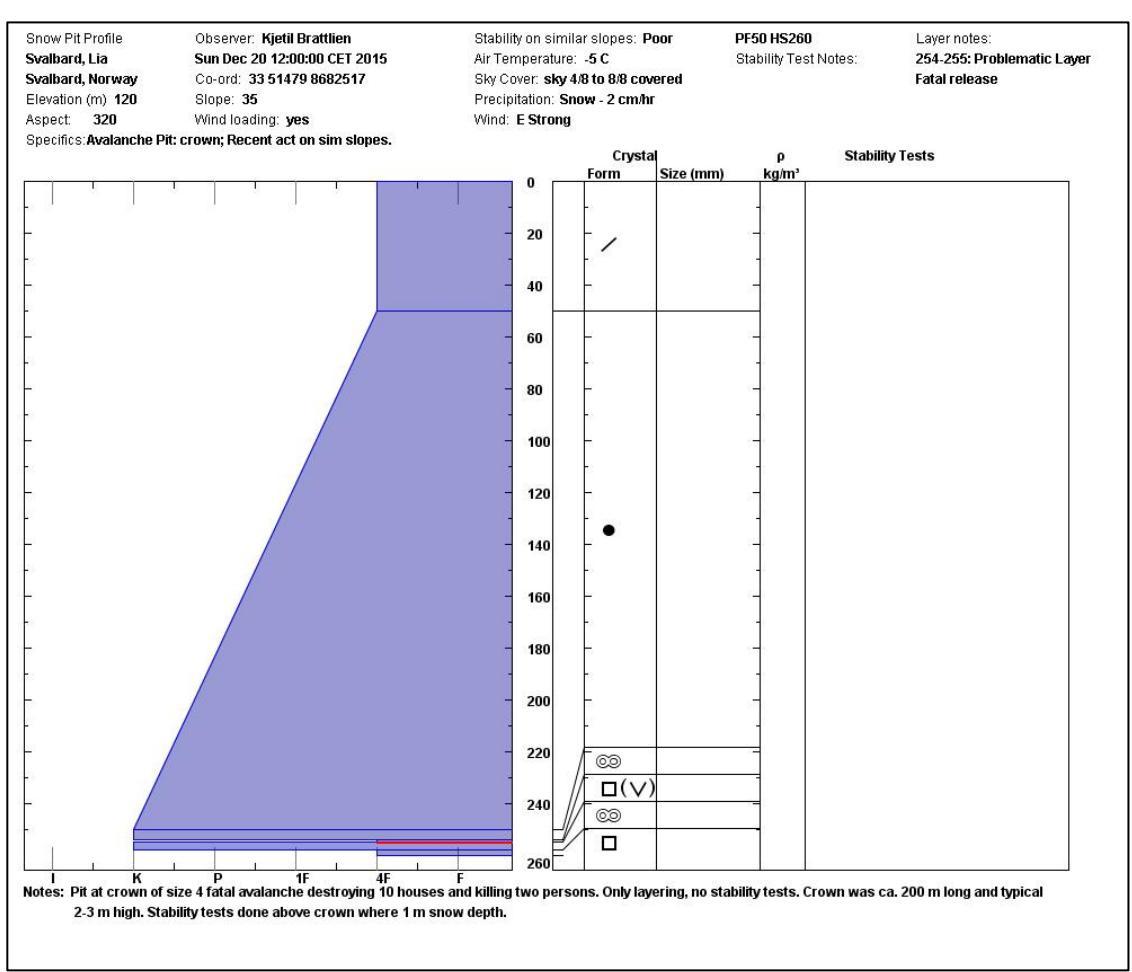
Figure 5.2.1: NGI pit at avalanche crown 25 hours after the release.

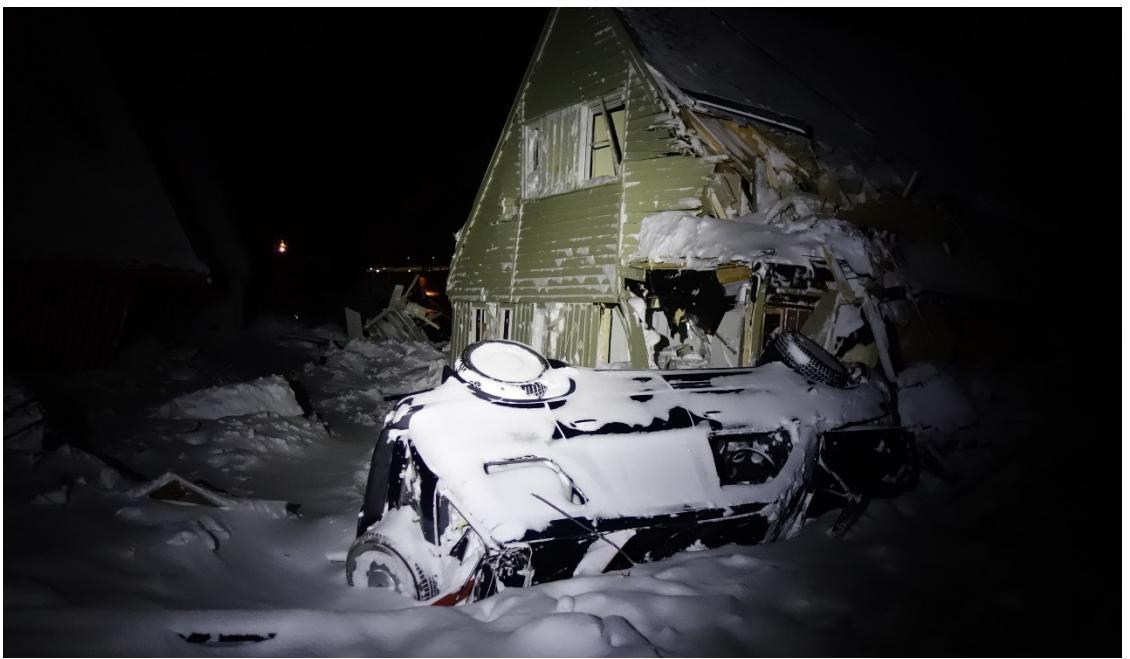
NGIs investigation of the damage caused by the avalanche showed more damaged on the first floor in houses than higher above the ground. Photo 5.3.1 shows an example of this. Photo 5.3.2 shows the powder cloud above and in front of the avalanche just before it stops.

Photo 5.3.1: Upper row house 230/30 moved 80 m by the avalanche. Photo: Kjetil Brattlien.

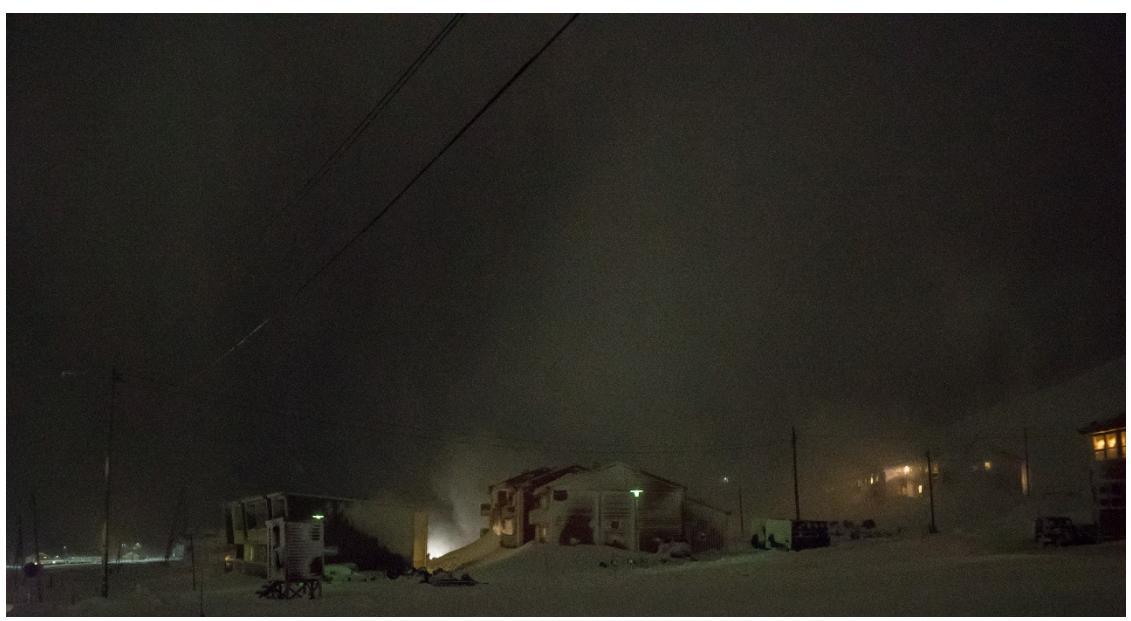
Photo 5.3.2: Powder cloud above and in front of the avalanche just before it stops. Photo: Tommy Markussen.

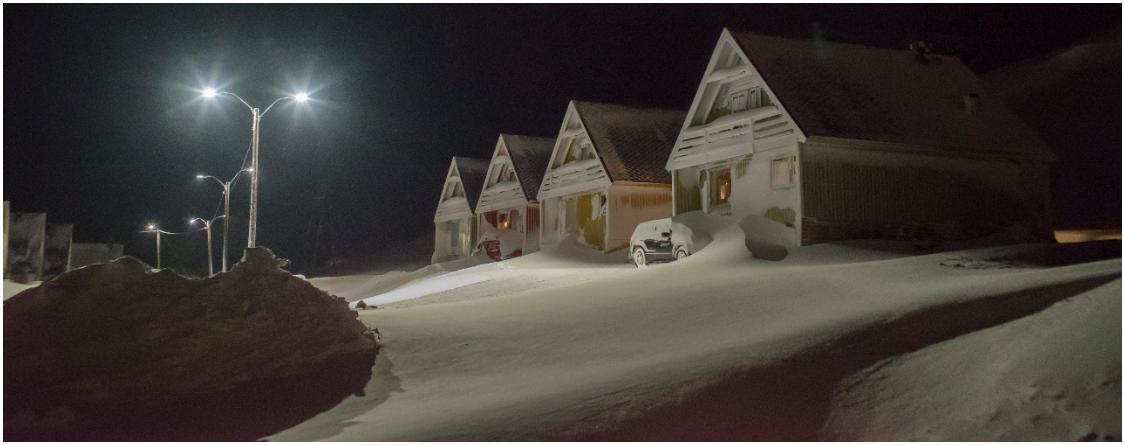
All street lights where taken by the avalanche except the pole 15 m from house 230/16 that was intact except for one of the two solid metal lamp fixtures being broken off. Damage to the street light about 6 m above the ground (height assumed by NGI) near the side of the avalanche indicate avalanche load also high above the ground. It cannot be excluded that the poles and electrical cord where damaged by the houses when they

Photo 5.3.3. The upper row with 4 houses and street light below just before the avalanche. The two closest poles were completely destroyed by the avalanche. Photo: Tommy Markussen.

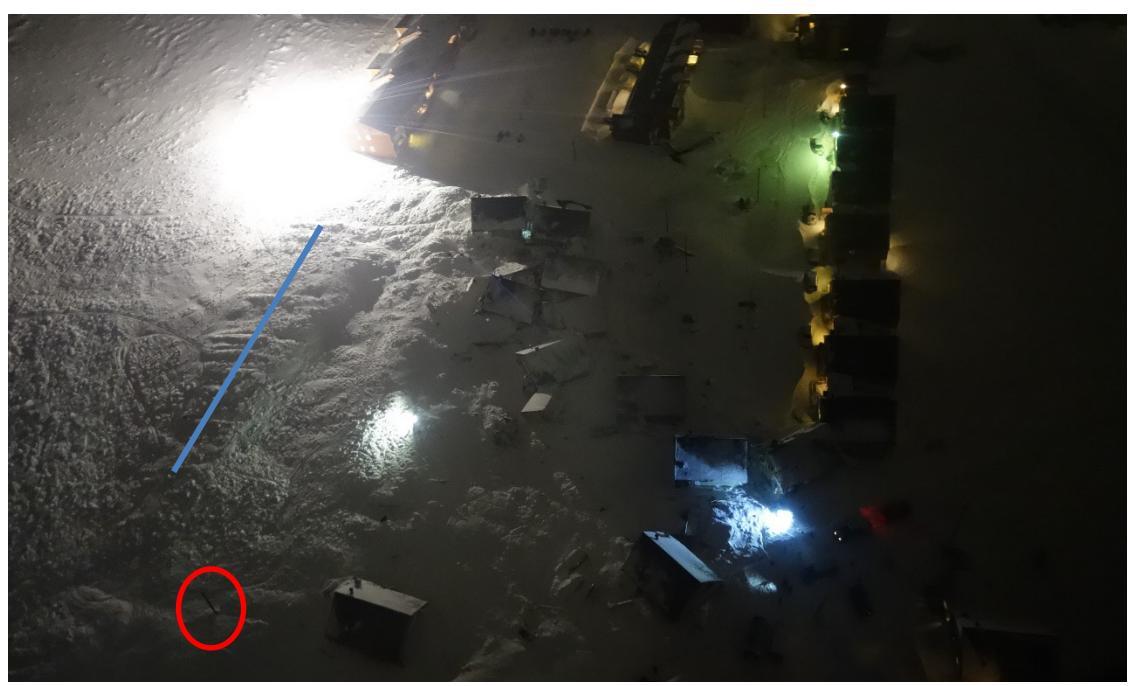
moved past the area. The load on the electrical cord could also have caused damage to the metal lamp fixture on the street light outside house 230/16.

Photo 5.3.4: Picture one day after the avalanche. Blue line is ground for upper row of houses, red ring is the remaining street light pole. Photo: Kjetil Brattlien.

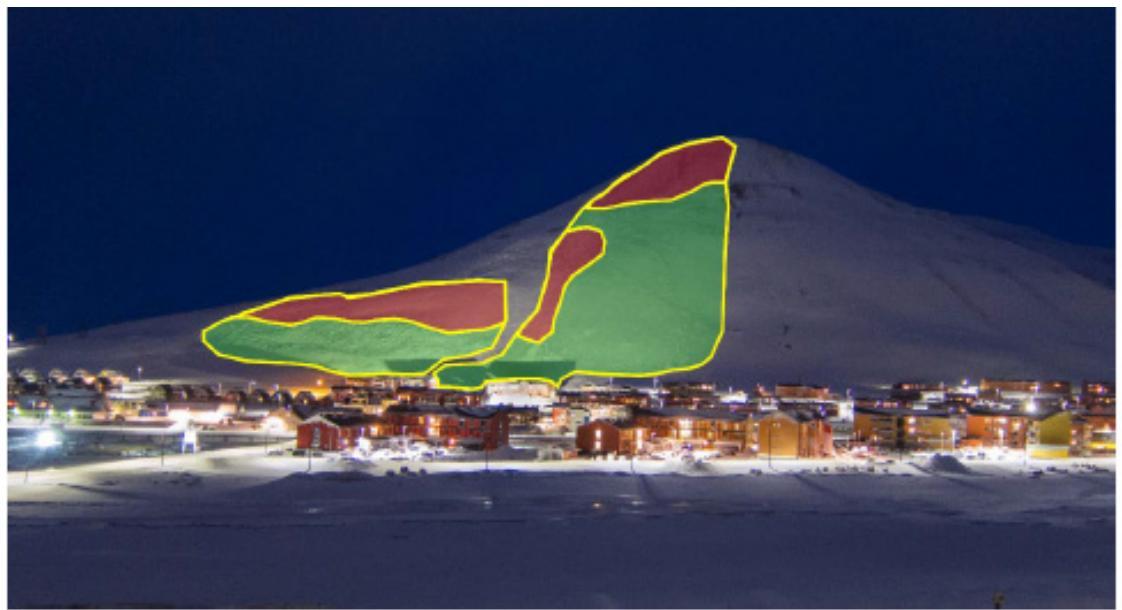
Photo 6.1: Illustration of 2017 avalanche with assumed release areas (red) and runout area (green) from NVE (2017).

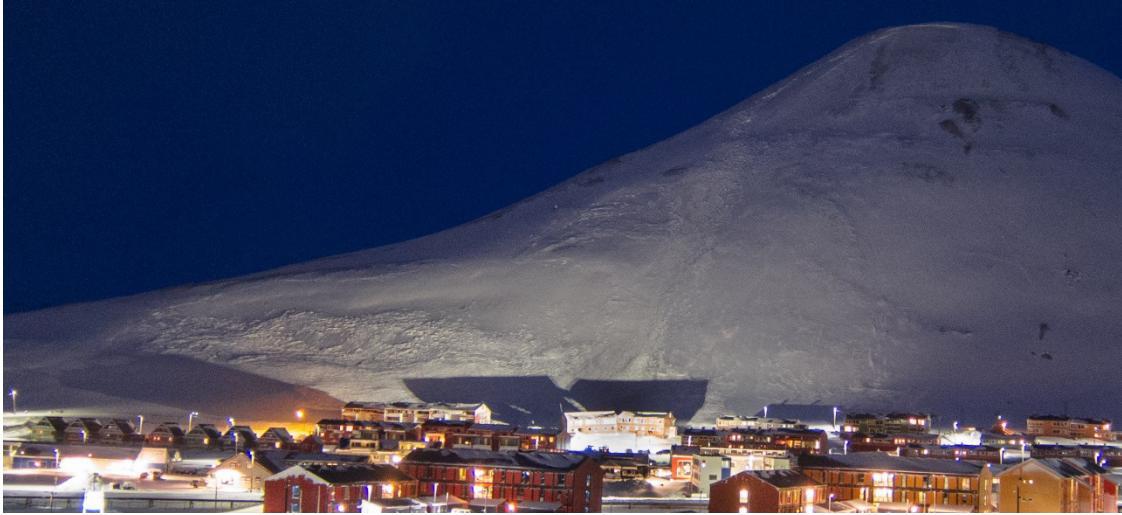
Photo 6.2.1: Overview of 2017 avalanche. Photo: Arnt Rennan.

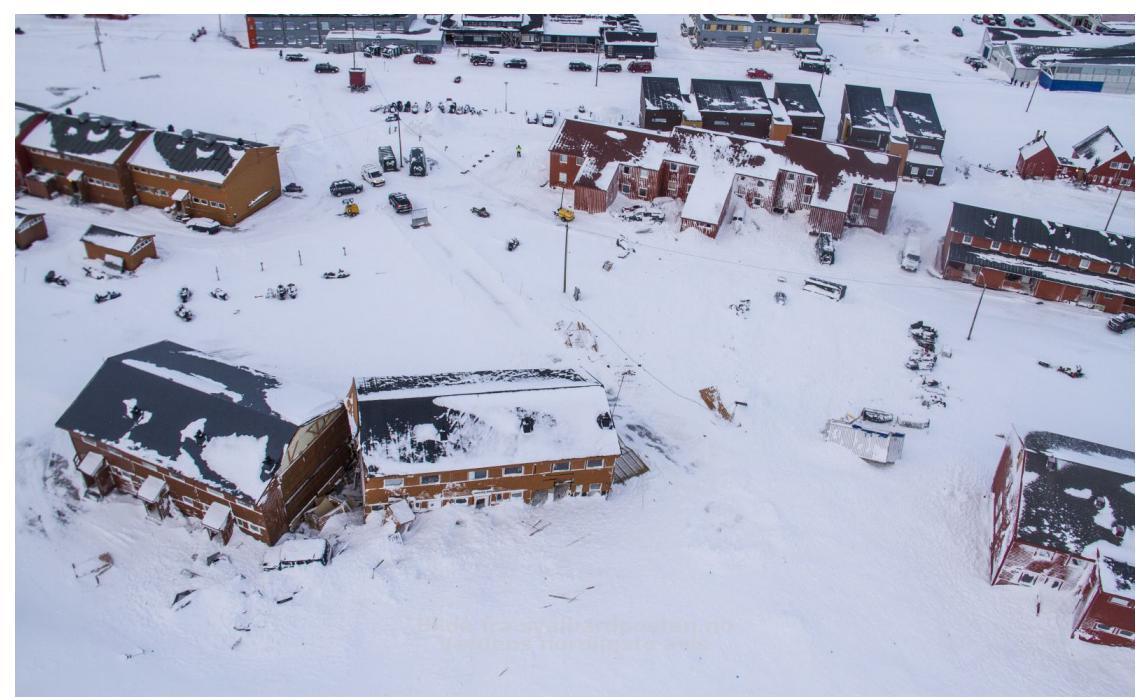
Photo 6.2.2: Aerial photo of 2017 avalanche. Photo: Sysselmannen.

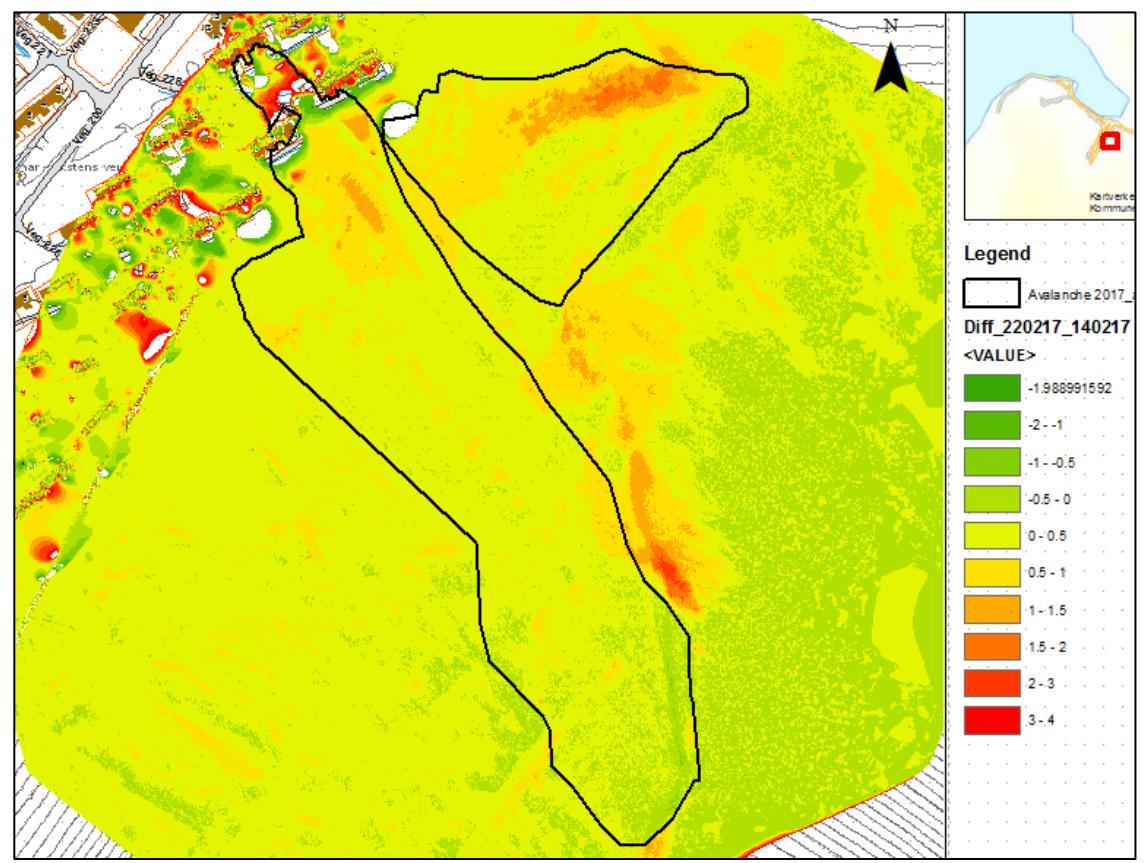
Figure 6.2.1 shows the difference between scans 22nd and 14th February. Snow deposition has increased most places from 14th to 22nd February. The exception is the top release area (around 350 masl) where green colors indicates typically 0,5 m less snow.

Figure 6.2.1: Difference between scans 22nd and 14th February (positive numbers is increase in snow deposition).

Figure 6.2.1 shows typically less than 0,5 m difference between scans in the upper part that released (350 masl). It is uncertain how much snow deposited in the lee slope in the 7 days with snow and wind between 14th February and the release 21st February. If 0,5 m was deposited the typical fracture height could have been around 1 m, if 1 m was deposited the fracture heights could be 1,5 m etc.

Figure 6.2.1 does not show clear results and likely fracture heights in the lower release area (80-200 masl) of the same track. The figure does not show clear results and likely fracture heights in the release area at the shoulder at 125 masl either.

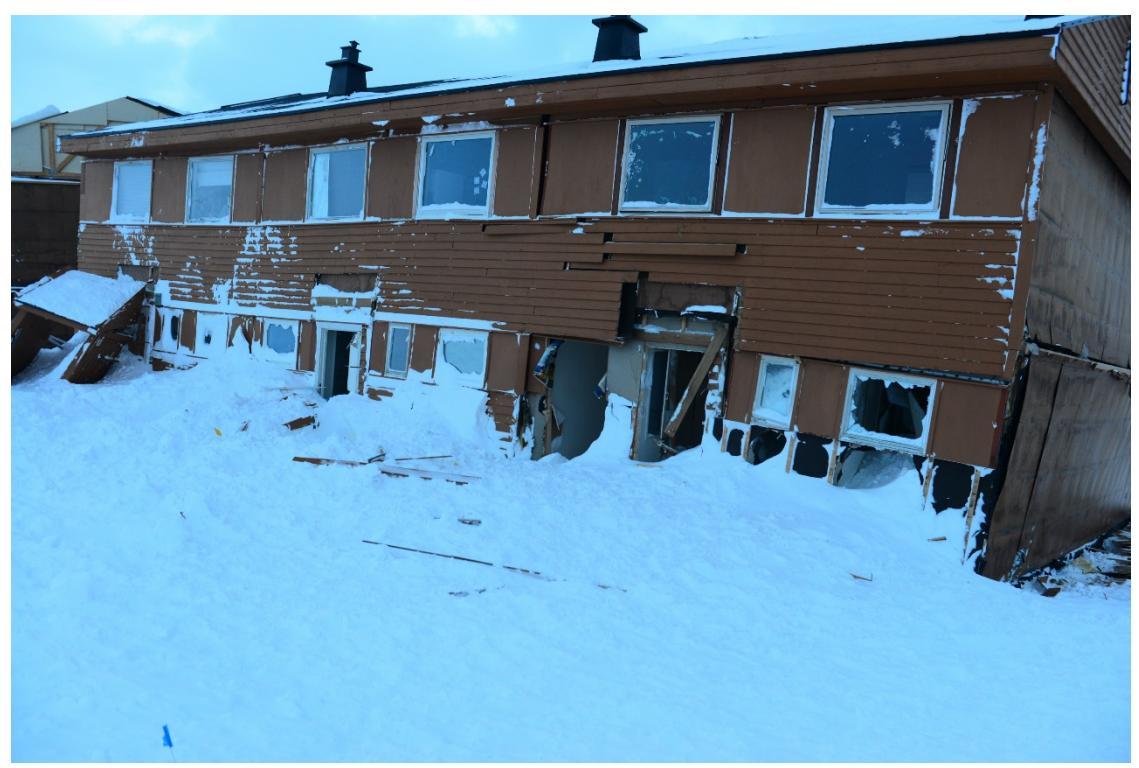
The dense part of the avalanche did most damaged. Pictures below show damage from the avalanche. Note that the pictures indicate that the avalanche had a powder cloud that also did damage.

Photo 6.3.1: House 228/6-10 after the February 2017 avalanche. Photo: Christian Jaedicke.

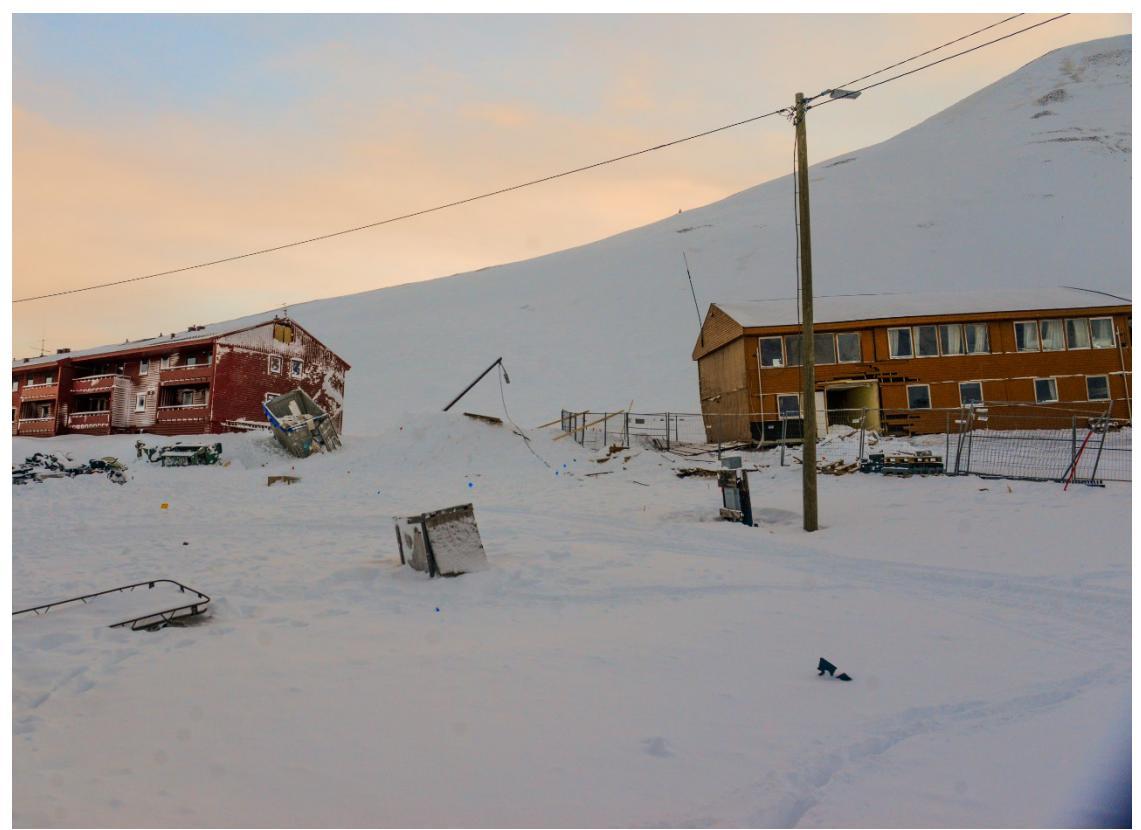
Photo 6.3.2: Road 228 after 2017 avalanche. Photo: Christian Jaedicke.

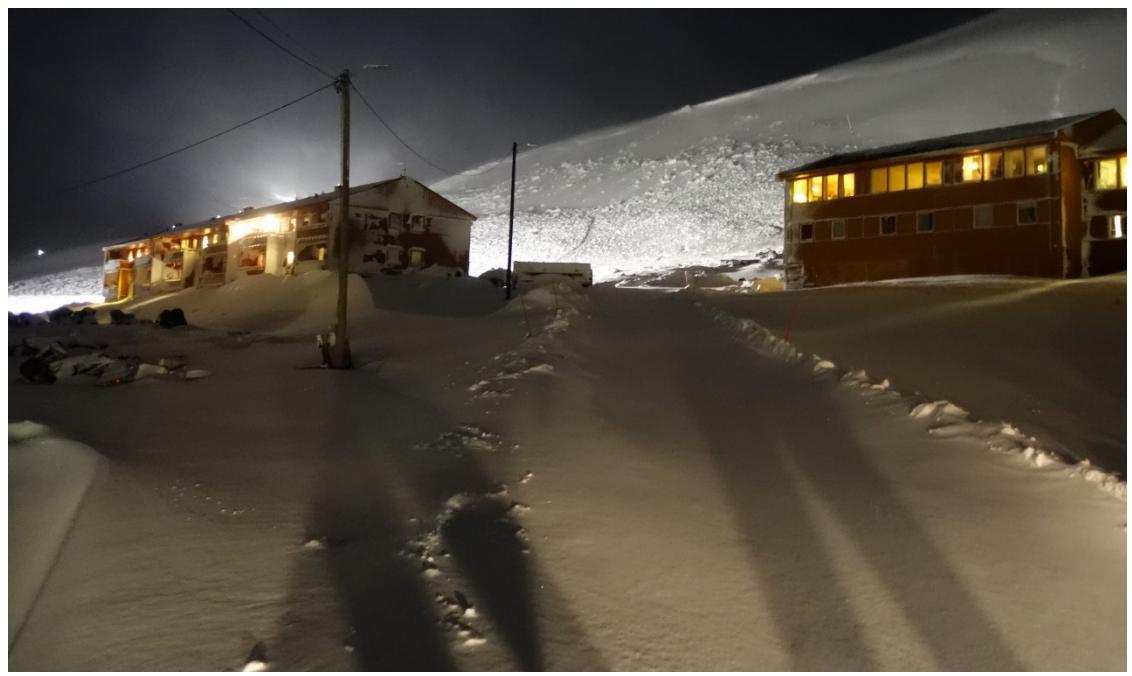
Photo 6.3.3: Road 228 after the 2015 avalanche. Photo: Kjetil Brattlien.

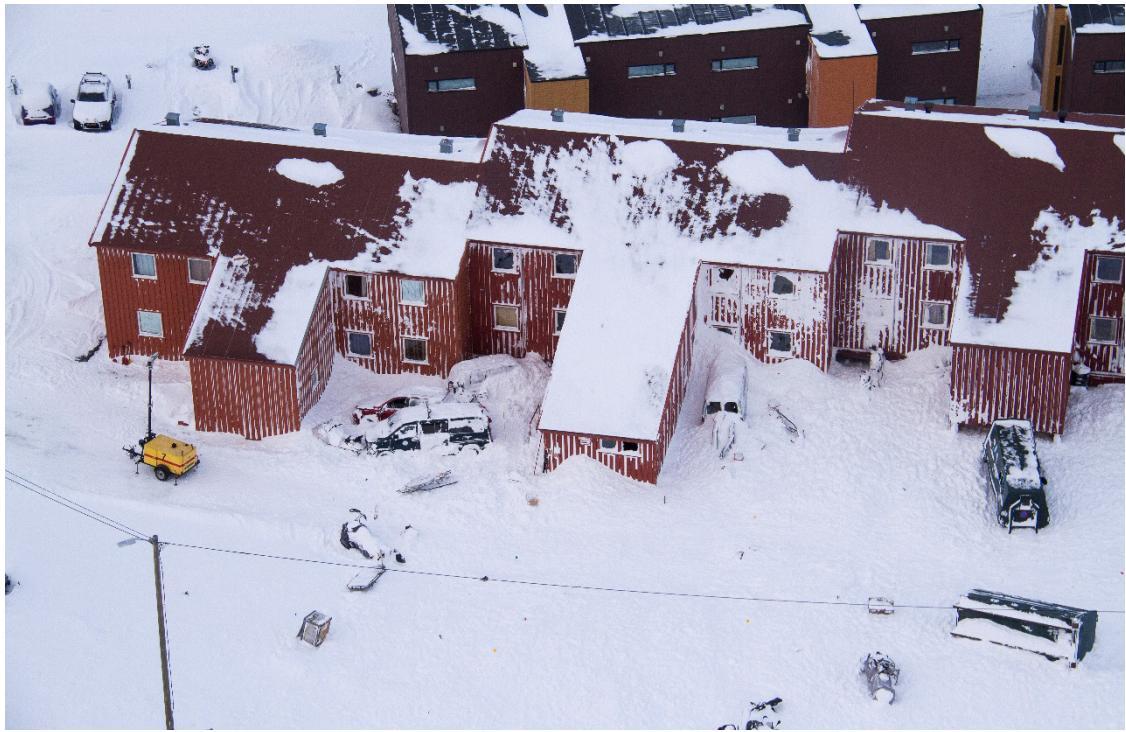
Photo 6.3.4: House 228/7-11 after the 2017 avalanche. Photo: Sysselmannen.

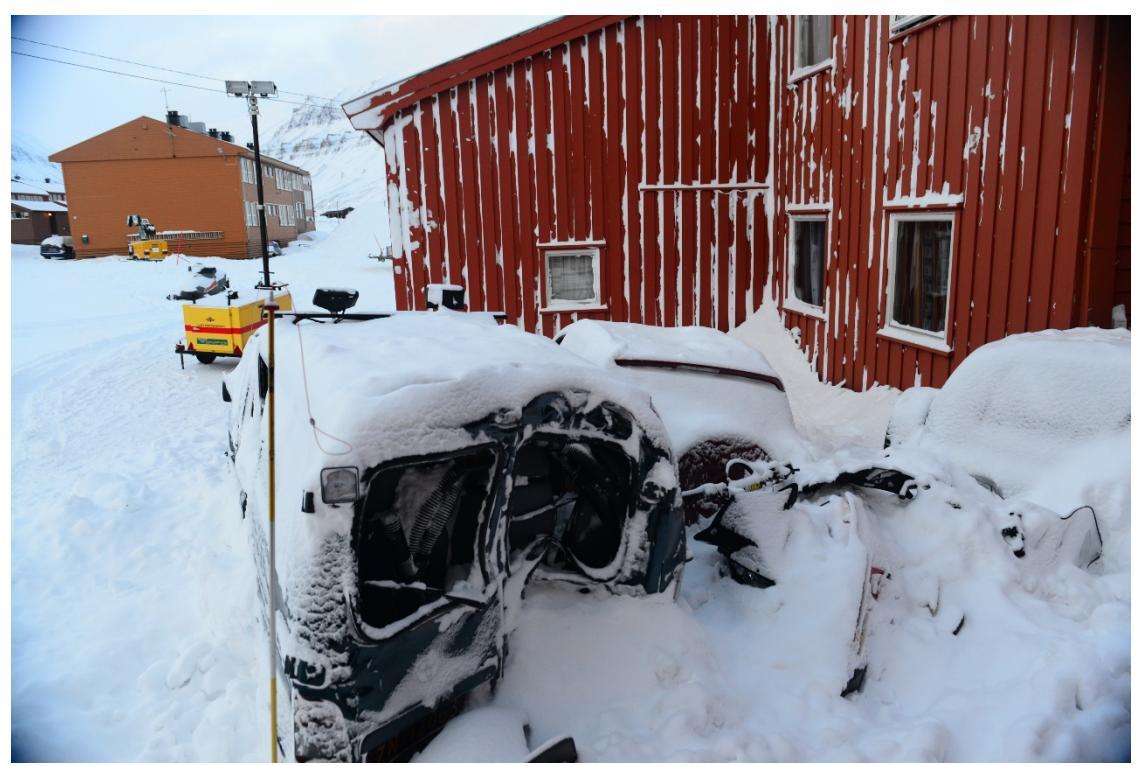
Photo 6.3.5: Damage on vehicles outside house 228/7-9 after the 2017 avalanche. Photo: Christian Jaedicke.

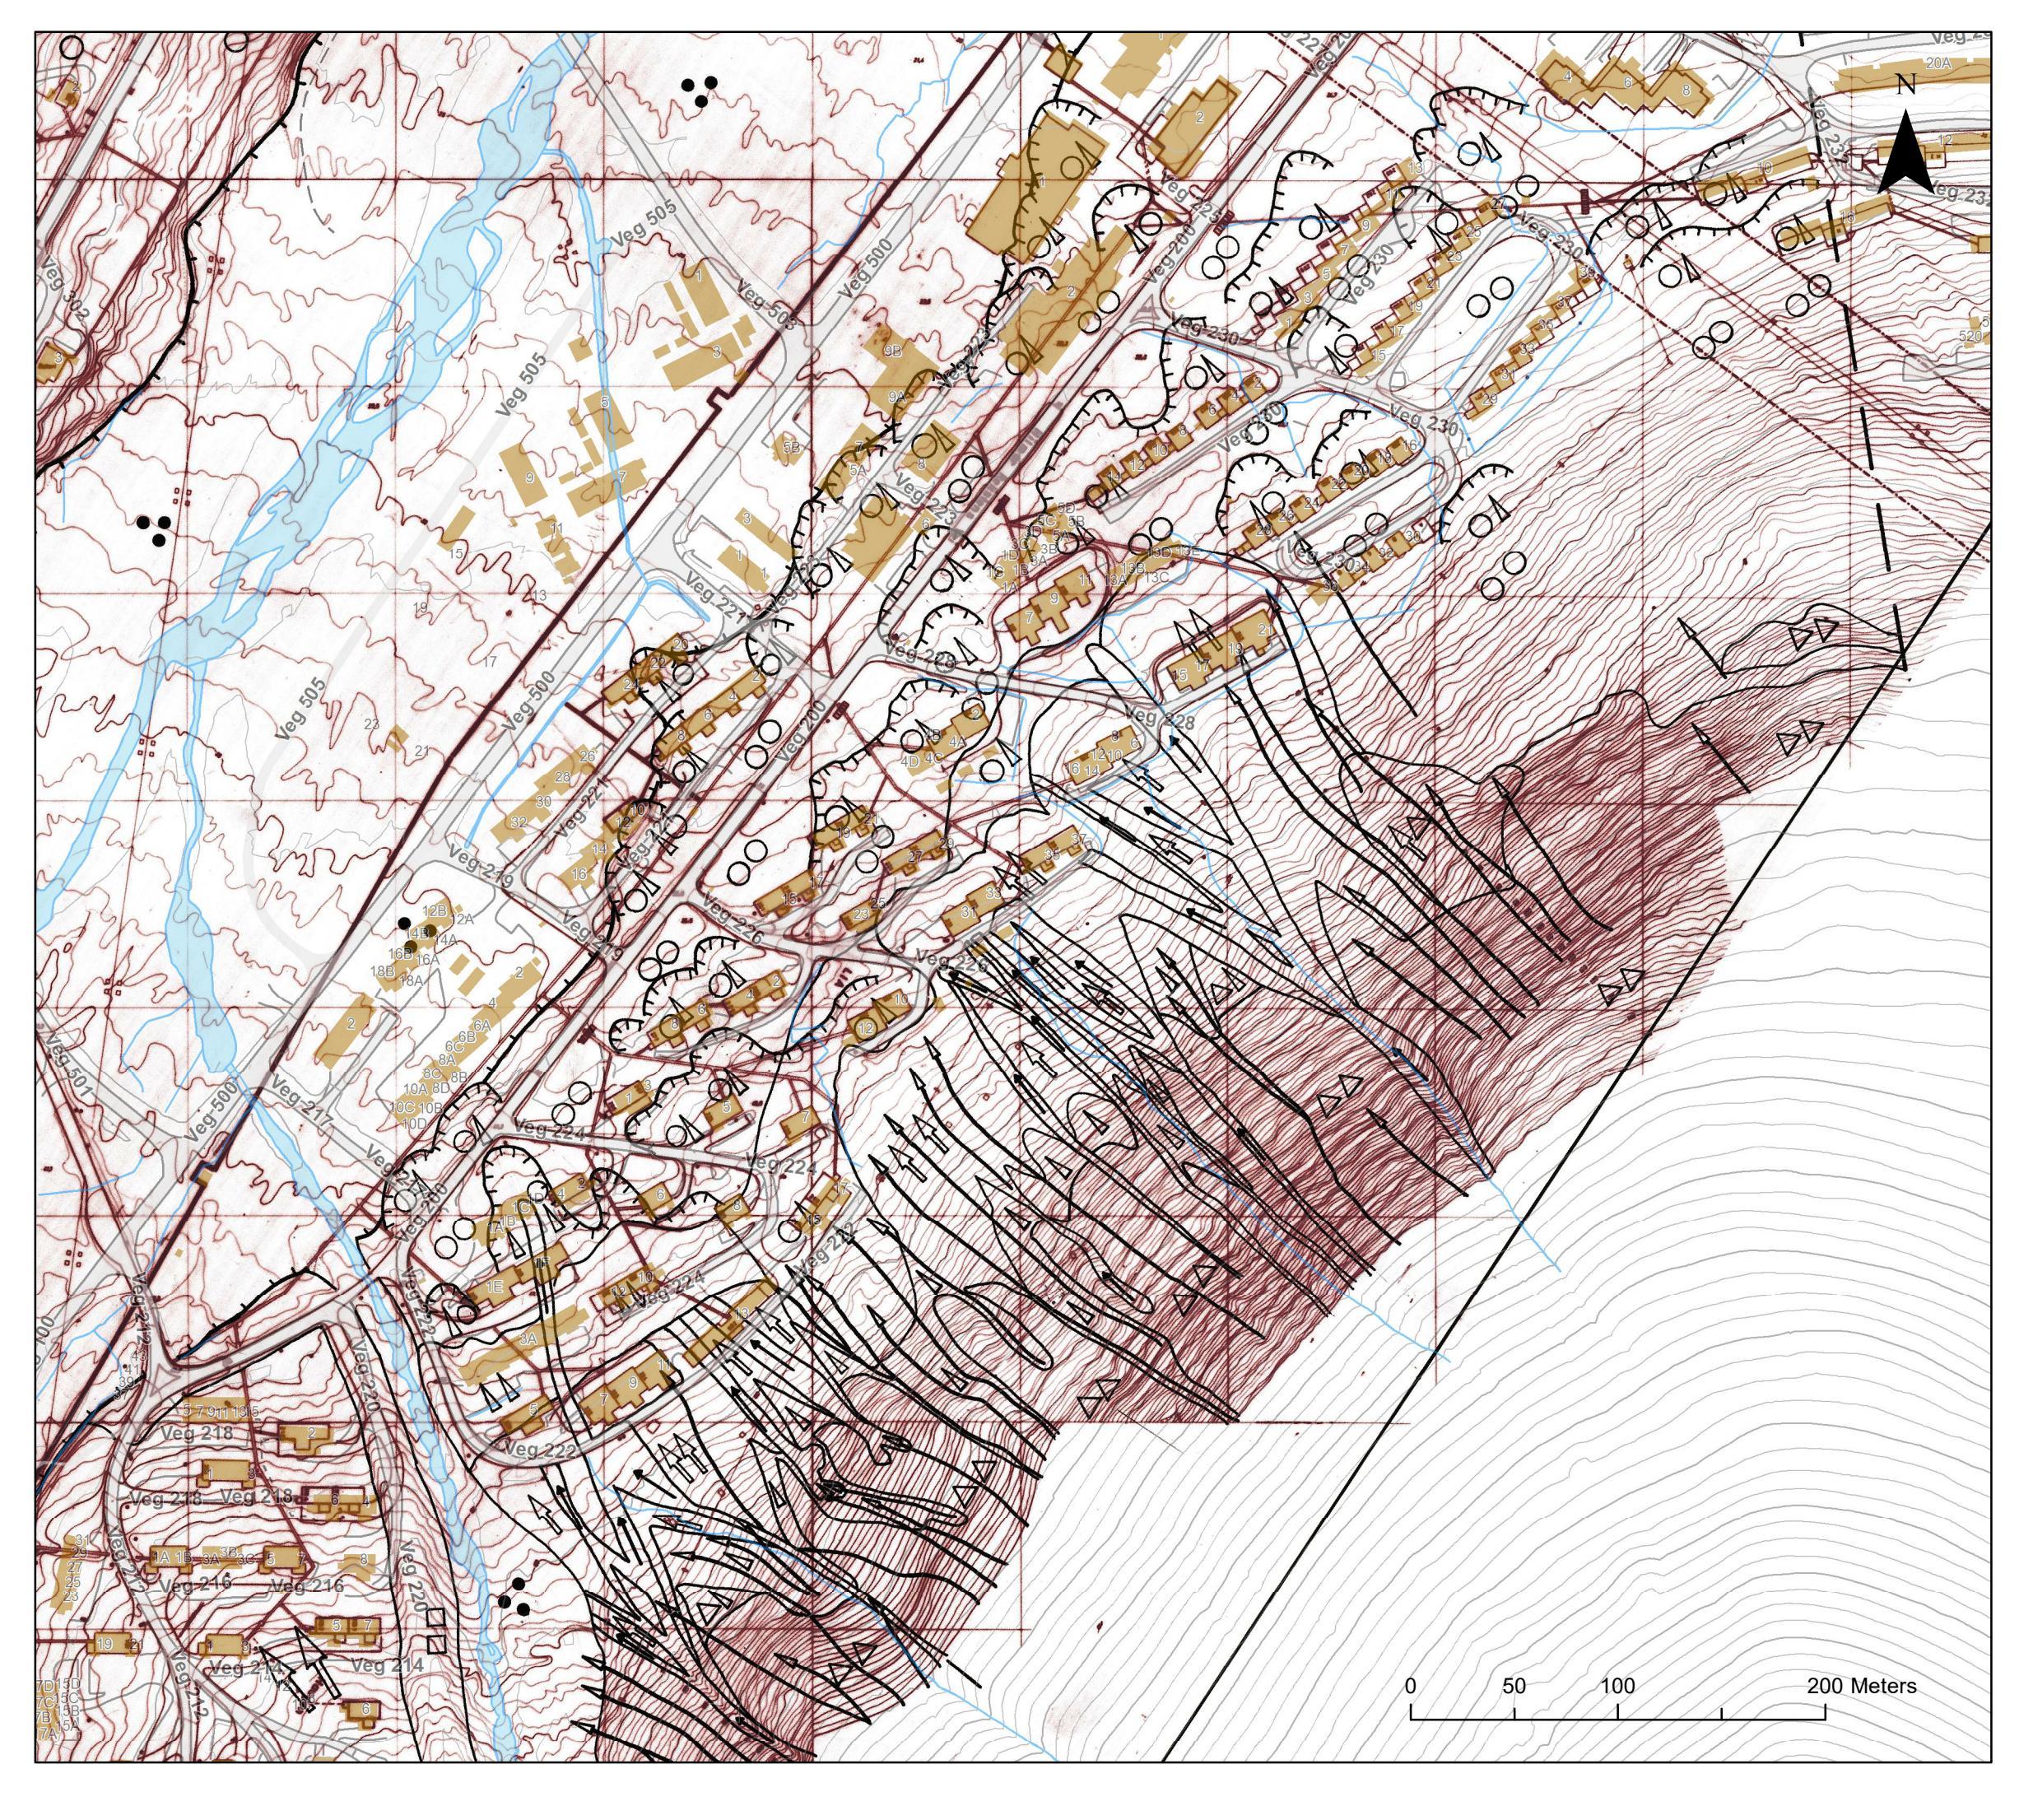
Map 1 in Appendix A shows deposits from debris flow and possible other types of mass movement from the 1985 mapping on a 2017 map with today's buildings. The map gives an indication previous debris flow runout, but does not consider destructive potential. Flow thickness and intensity decreases towards the longest reach of the debris. Hence, the maximum runout is probably not relevant for S1-S3 events with TEK17 regulations because it had not enough destructive power. On the other hand some of the debris flow depositions are relevant for TEK17 and the design scenario.

There were less buildings in the area in 1985 than today, and debris depositions not visible today were mapped. The 1985 NGI mapping shows that the buildings in road 220-230 are placed on deposits from debris flows and possibly other mass movements. The depositions extends also below road 200 (Hilmar Rekstens vei) and into road 221 and 223 in the city centre.
