Sukkertoppen Svalbard - avalanche incidents

DOCUMENTATION OF AVALANCHES

DOC.NO. 20171006-01-R REV.NO. 0 / 2017-12-11

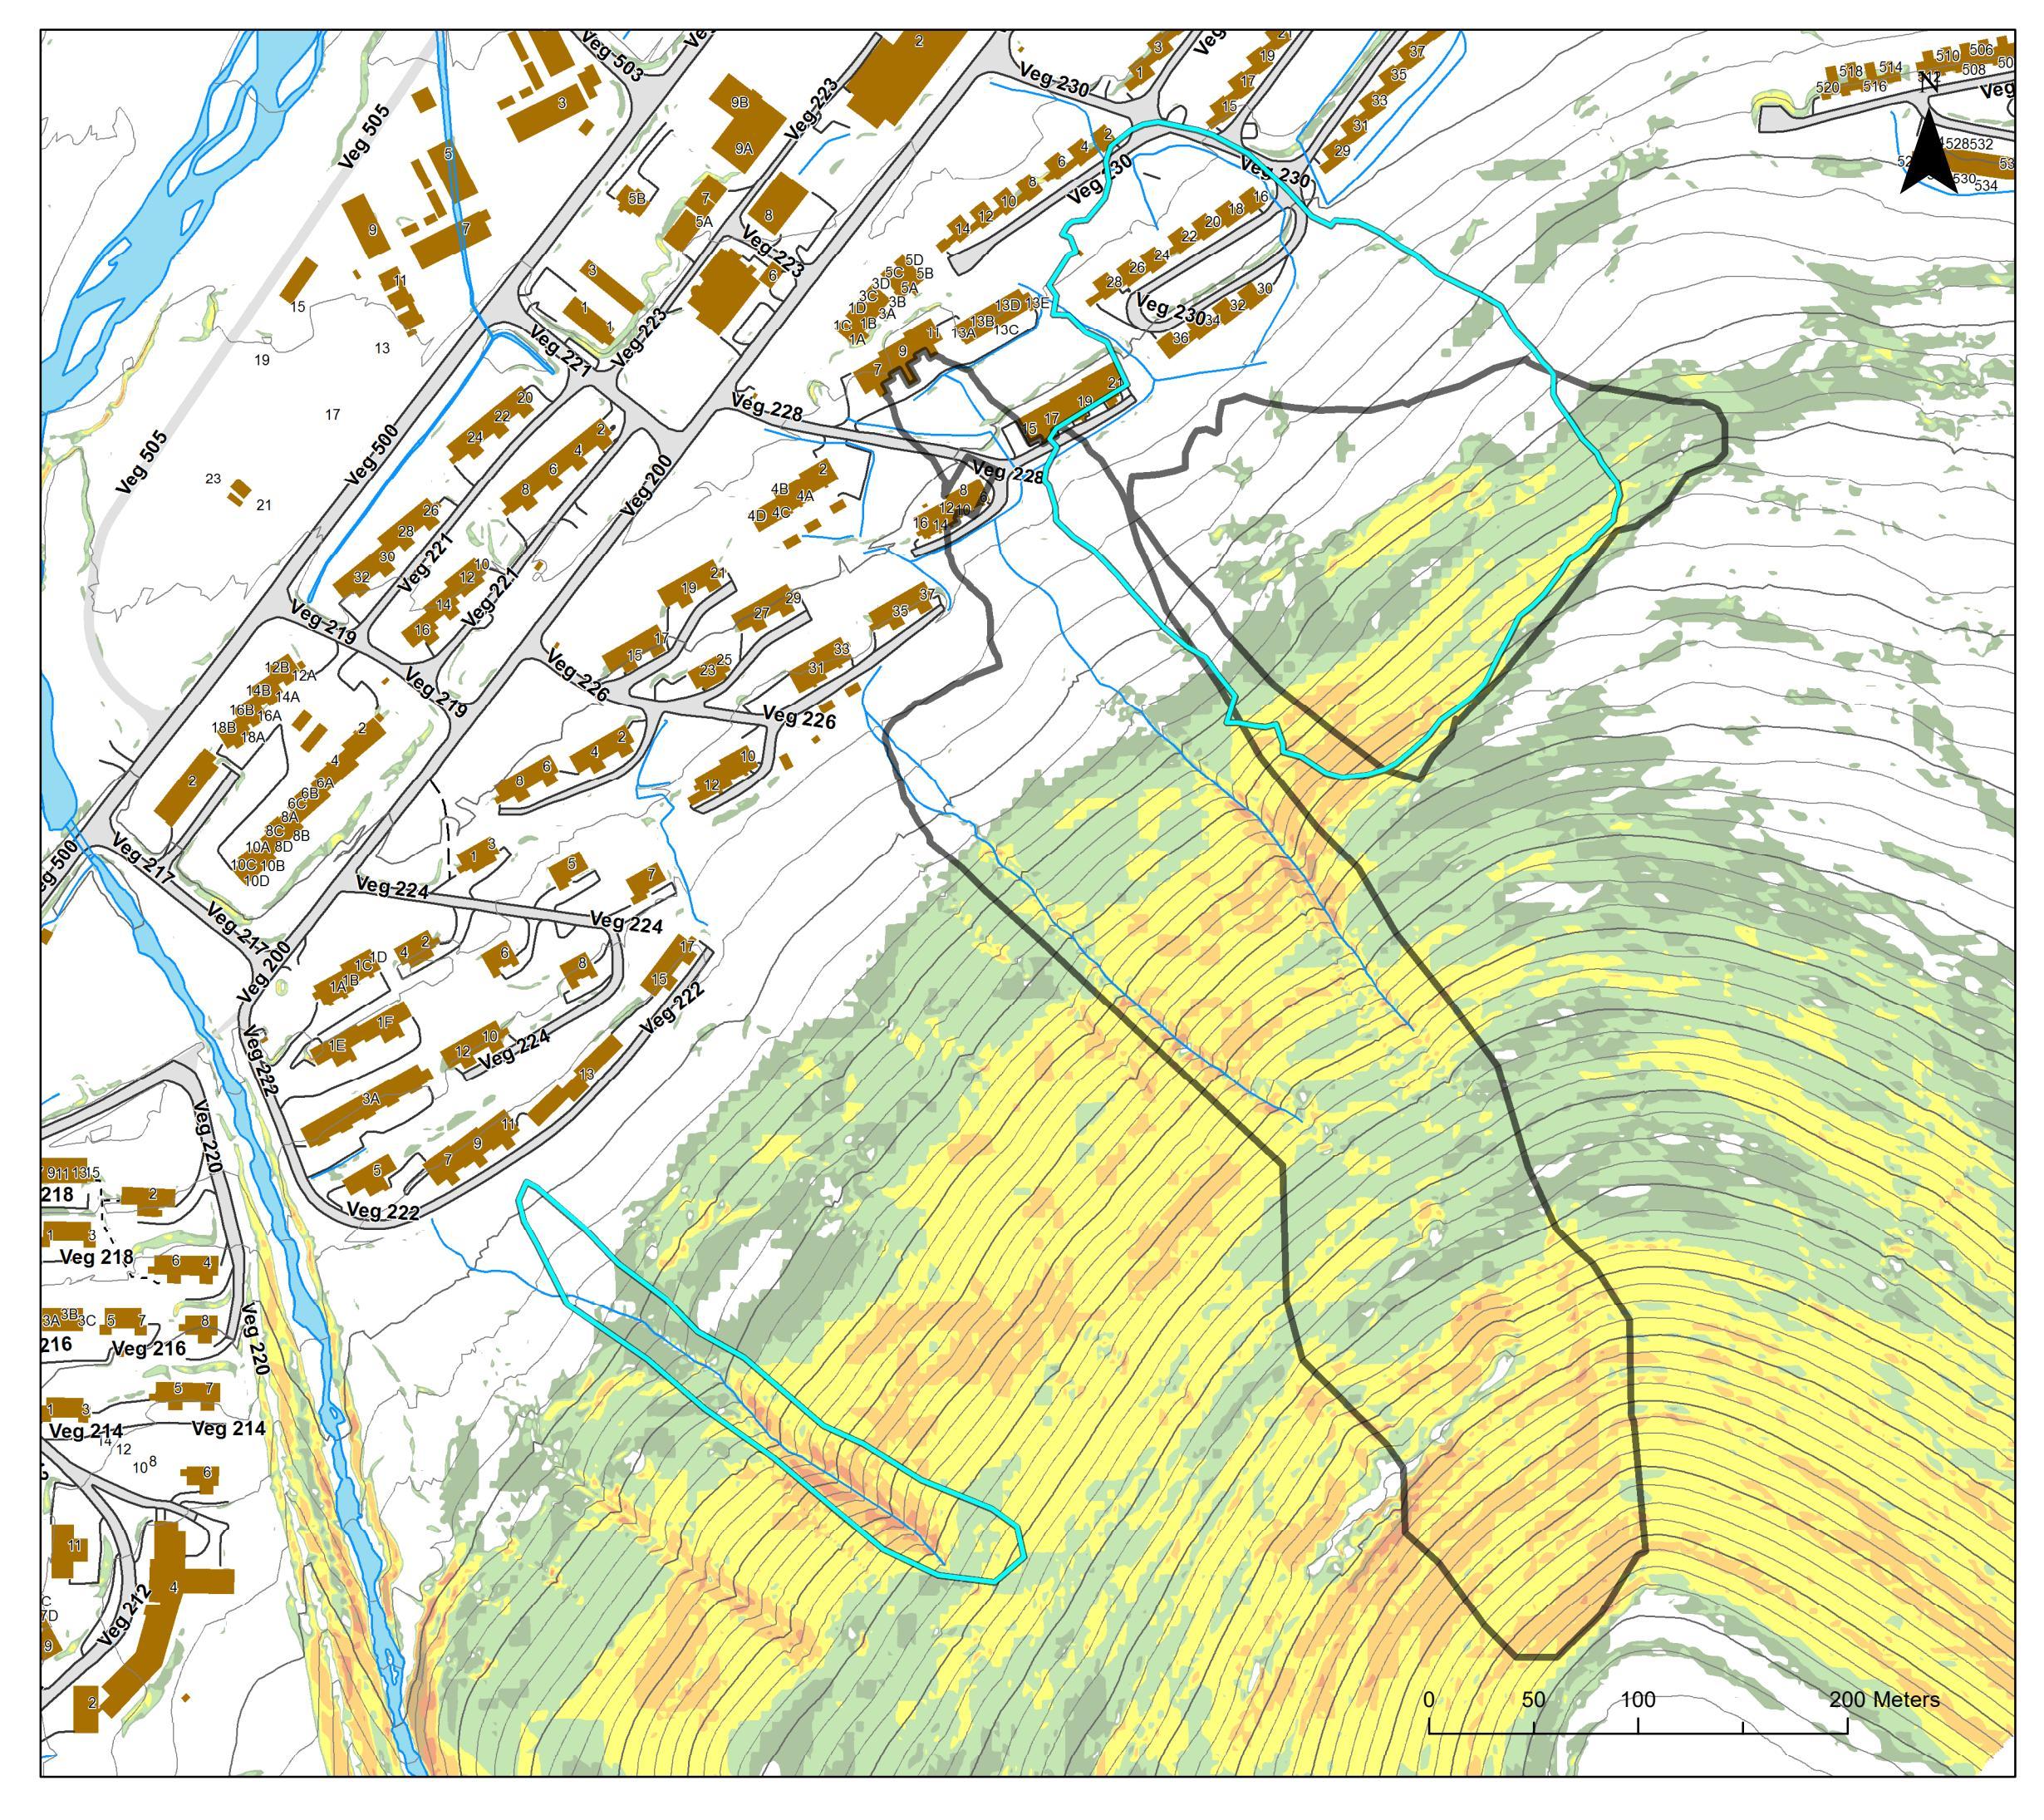
Map 2 in Appendix A shows the runout of the dense part of the debris map by NGI with hand held Garmin GPS walking around the debris. It is important to notice that runout was influenced by the buildings, and would have been longer without buildings.

Map 2 in Appendix A shows the maximum runout of the dense part of the debris map by NGI by points measured by differential GPS walking around the debris. It is important to notice that runout was influenced by the buildings, and would have been longer without buildings.

Map 2 also shows best estimate of side and top limitation of the avalanches. This is mainly bases on laser scanning done by UNIS before and after the avalanche.
