**Impact of rapid mass movement and
drifting snow on the infrastructure and
development of Longyearbyen, Svalbard**

by Erik Hestnes

589100-2

August 1994

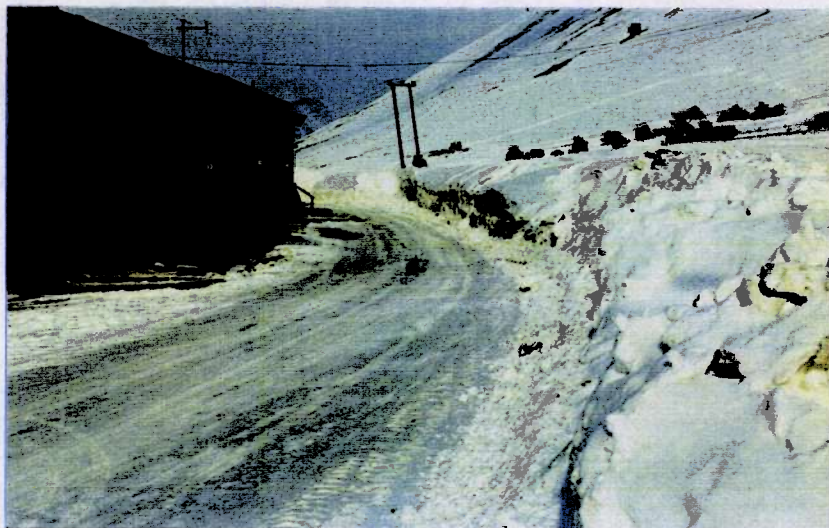
Figure 7: The access to houses along road 222 is frequently blocked by snowdrift.

Mitigation of the snowdrift about the roads 222 and 226 is planned by means of snowfences (Fig. 7). The location and dimensioning of the fences are based on

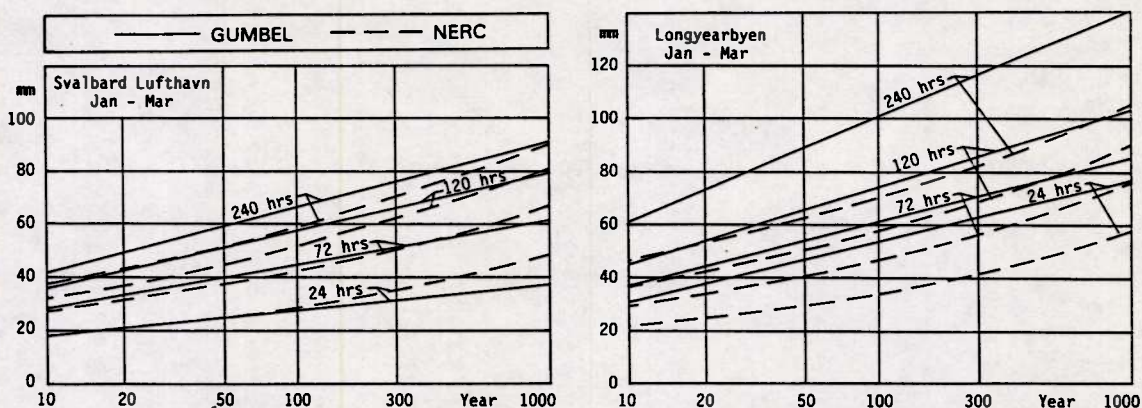
Figure 10: Precipitation prognosis according to Gumbel and NERC.

However, the reliability and representativity of the records are questioned. For instance: The recordings of precipitation at Svalbard Lufthavn are known to be too low. On the other hand, could the rain gauge at Longyearbyen have caught too much during heavy storms? The Gumbel and NERC prognosis of Svalbard Lufthavn have almost identical elapse, while the observed extreme values of Longyearbyen fit with the Gumbel prognosis, but not with the NERC prognosis. The deviation in January-March is between 10-38% (Fig. 10). Consequently, uncertainties concerning the return period of extreme precipitation arise when the basis for the prognosis is questioned (Førland 1987).
