Report on the 14-15 October 2016 mass movement event in the Longyearbyen area

Hanne H. Christiansen
Wesley Farnsworth
Graham L. Gilbert
Holt Hancock
Ole Humlum
Brendan O'Neill
Alexander Prokop
Sarah M. Strand

The University Centre in Svalbard, UNIS,
Arctic Geology Department, vers. 2 from 24 October 2016

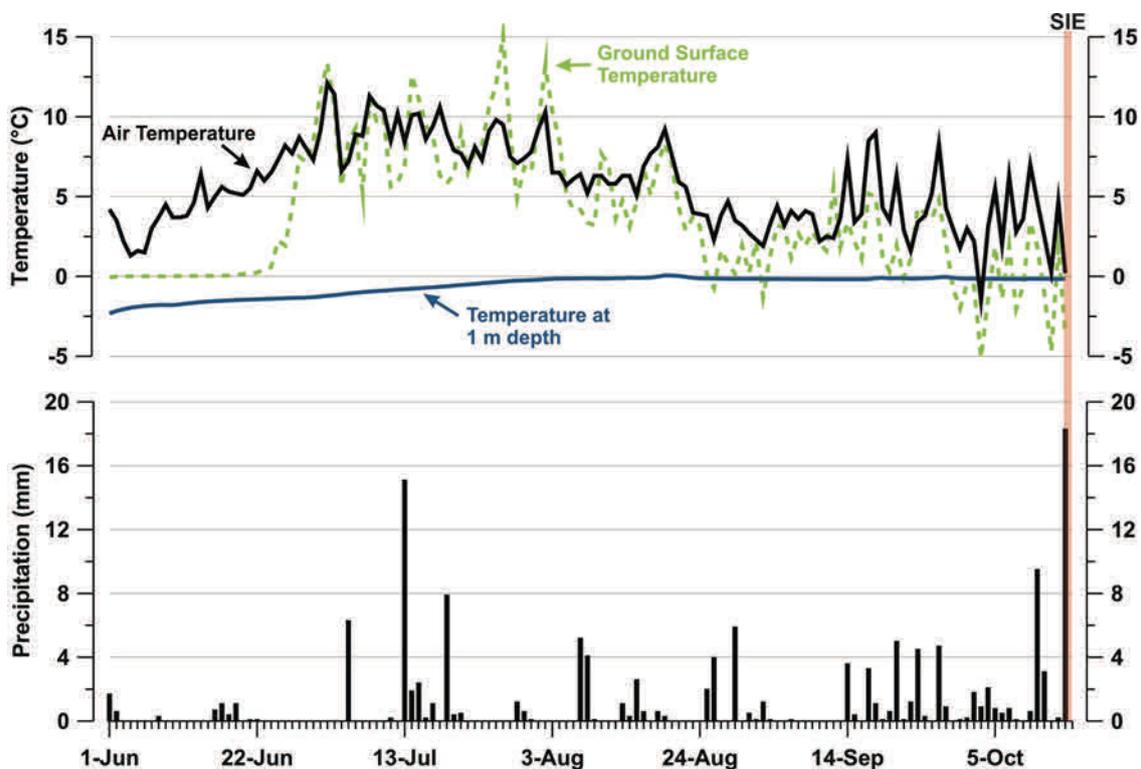
Figure 1. Daily meteorological conditions leading to the observed slope instability event (SIE) on 15 October, 2016. Mean daily rainfall and air temperature are recorded at the Longyearbyen Airport (28 m a.s.l.) from [eklima \(met.no\)](http://eklima.met.no). Ground temperatures are from the Gruvefjellet meteorological station at 464 m a.s.l. (UNIS online meteorological station).

The air temperature at Svalbard Airport since June 2016 has been above the average for the previous 30 years, especially in June, July, and September (Table 1). Generally, the air temperature has decreased since August, but there had only been one day with an average temperature below 0°C until 15 October (Figure 1).

Due to the warm autumn, the active layer – the layer that freezes and thaws seasonally above permafrost – was largely unfrozen during the event. The ground surface at 464 m experienced freezing in late September and early October, but only for short periods (Figure 1). In combination with the high precipitation amounts in summer 2016, additional moisture added to the active layer during the high intensity event created saturated conditions that allowed mass movements in different forms. Commonly, the ground surface near Longyearbyen will have started to freeze downwards by mid-October, but due to the mild 2016 autumn this freezing had not commenced, and the active layer was close to its maximum thickness on the slopes during the event. Therefore, there was unfrozen ground typically greater than 1 m in depth available for mass movements. On Gruvefjellet, the active layer was about 1 m thick, indicated by the 1 m ground temperature at or just below 0°C (Figure 1).

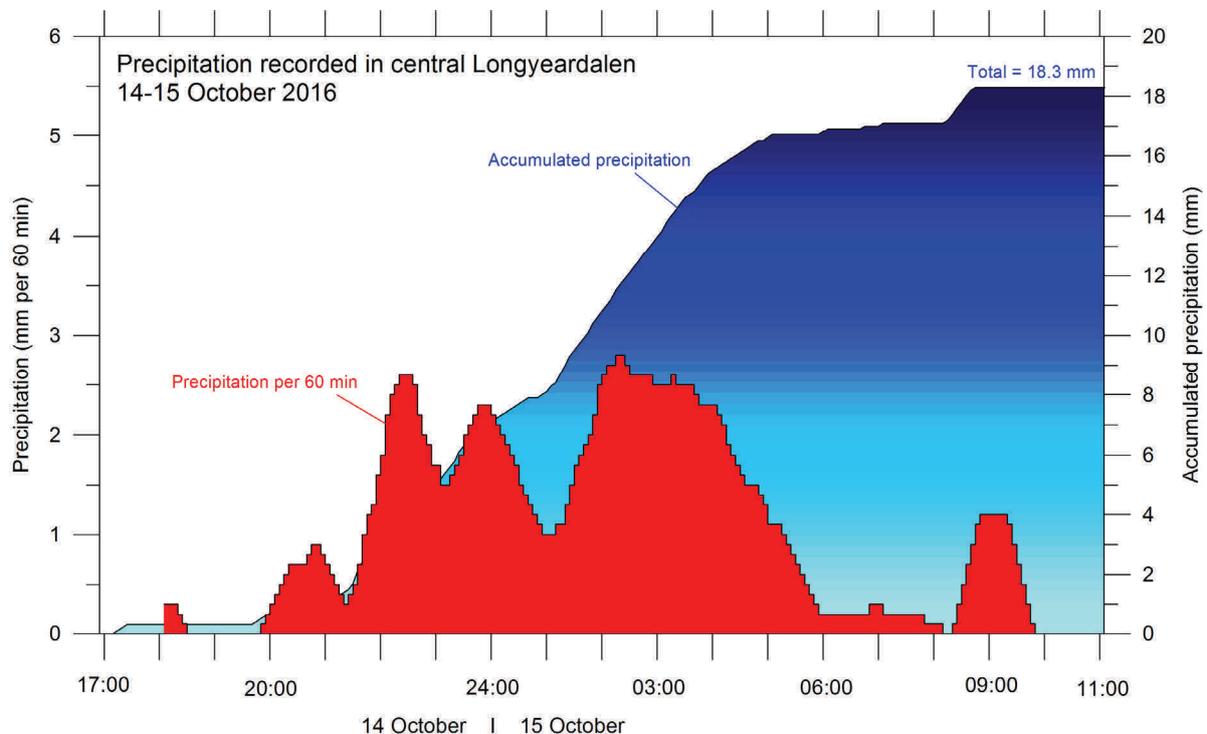
Figure 4. The red region shows the calculated 60-minute intensity (the amount of precipitation during the previous 60 minutes, plotted in 5-minute steps) of precipitation from Friday 14 October at 17:00 to Saturday 15 October at 11:00. The blue shaded region shows the accumulated amount of precipitation during the same period. In total 18.3 mm precipitation was recorded in this period by the data logger. The highest 60 minutes (1 hour) intensity recorded was 2.8 mm/hour, at around 2:00 October 15.

We also installed two precipitation gauges in the middle of Longyeardalen (at about 45 m altitude) in the late afternoon, 14 October. The instruments were programmed to record the amount of precipitation every 5 minutes (Figure 4).

A previous investigation (Larsson, 1982) suggested a rain intensity of 2 mm/hour as a critical value for the release of active-layer detachment slides, debris flows and mudflows in the permafrost environment around Longyearbyen. This result was based on another major precipitation event on 10-11 July 1972, where 30.8 mm of rain fell within 12 hours, and a high number of slides and mudflows were released on both sides of lower Longyeardalen valley. The precipitation measurements from 14-15 October 2016 lend support to Larsson's conclusion based on the 1972 event, but the question about critical precipitation intensities clearly requires additional observations and analysis before any concrete conclusions may be drawn.

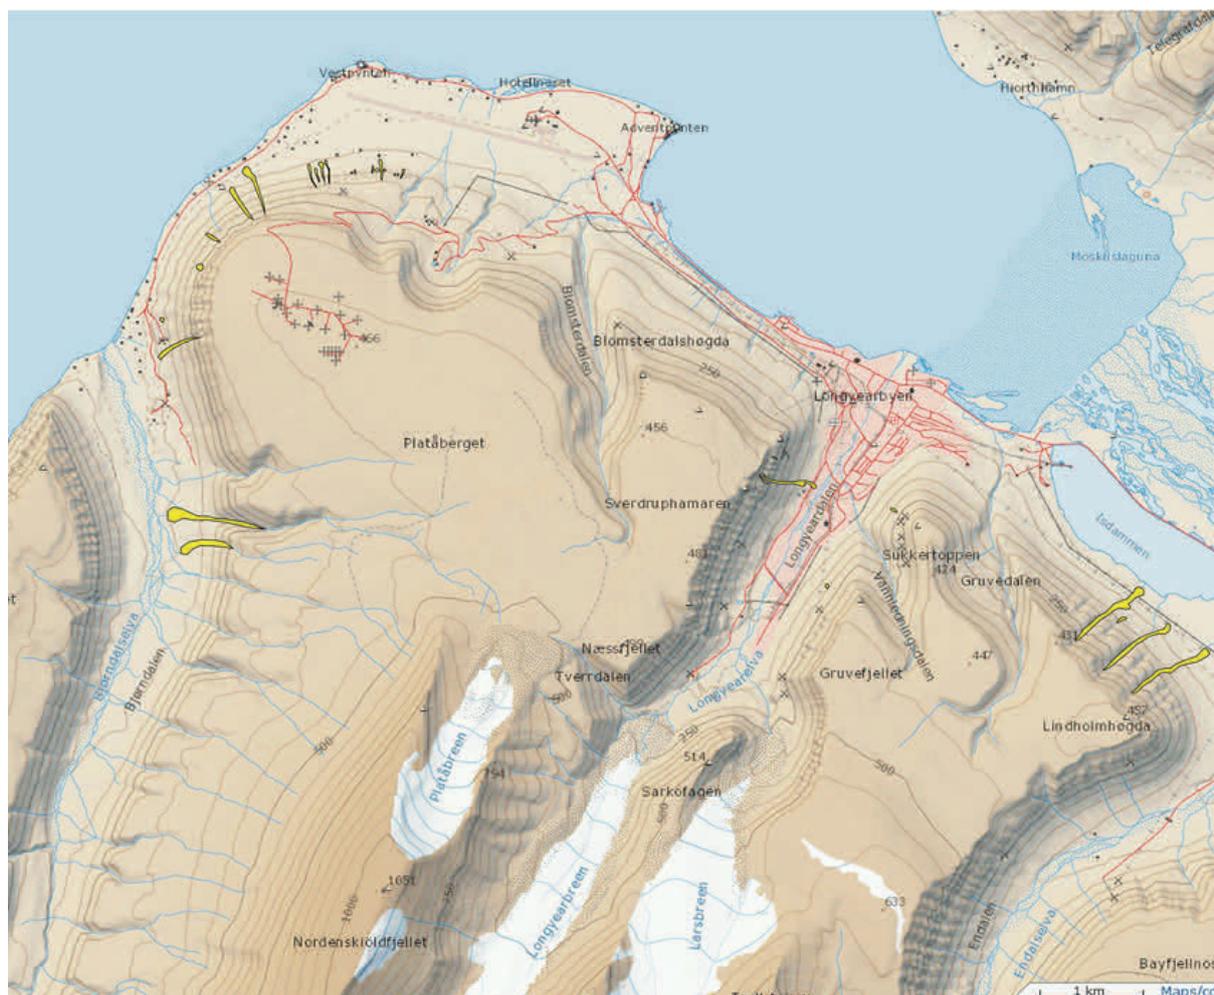
Figure 5. Mass movements (yellow) recorded on 15 and 16 October following the 14 -15 rain storm event. The mass movements were in the form slumps, active layer detachment slides and debris flows, and combinations of these.

All visible mass movements that occurred in the areas with road access around Longyearbyen were mapped on 15 and 16 October (Figure 5). The observed mass movements included slumps, slides, and flows. In several places minor slumps occurred, consisting of moving rotational masses that did not slide or flow (Figure 8 & 9). In addition, active-layer detachment slides and debris flow were observed (Figure 6, 7, 9 and 10). Adjacent to the Longyearbyen cemetery, a large active-layer detachment slide occurred, moving sediment downslope into 3 depositional areas, with the lowermost reaching within 50 m of the road leading up to Huset, just 10-15 m from the cemetery. Following the detachment slide, a debris flow initiated in the slide path, continued further down the slope over the road, and towards the river system, covering the road in mud and rocks (Figure 5, 6 & 7). During late morning on 15 October when sliding was still occurring, we observed blocks up to 25 cm moving quickly in the debris flow down onto the fan that crossed the road. Higher up on the slope, larger blocks were moving in waves of sediment downslope in the slide path that formed the debris flow. At around 13:00 most of the movement had ceased and the debris fan crossing the road started to freeze as the air temperatures dropped below 0 °C. As air temperatures decreased to below freezing during the early afternoon 15 October, water started accumulating in the lower slopes as frozen overland flow (Figure 8).

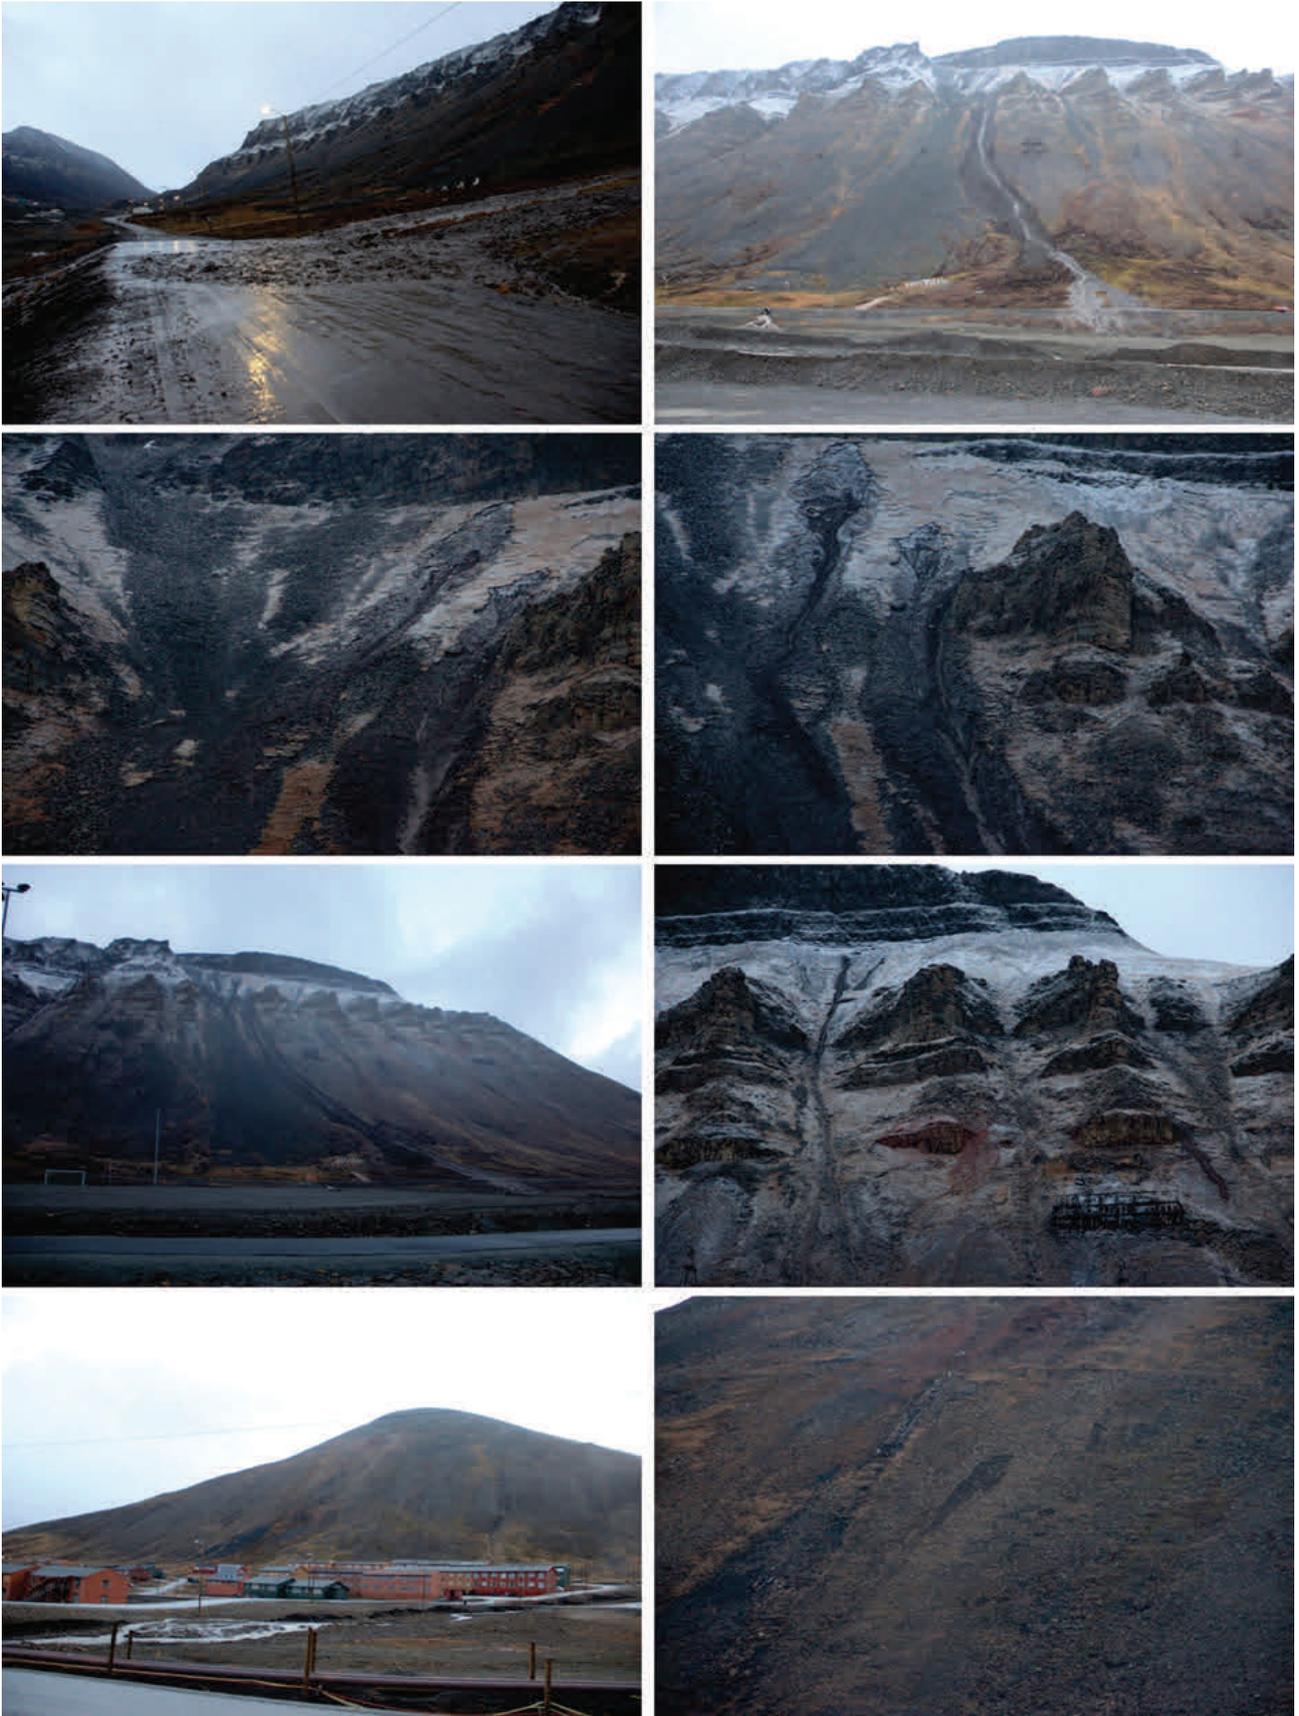
Figure 6. Overview and details of the active-layer detachment slide and debris flow in Longyeardalen valley at the cemetery, and a small slide on the opposite site of the Longyeardalen. Photos: Wesley Farnsworth, 15 October 2016.

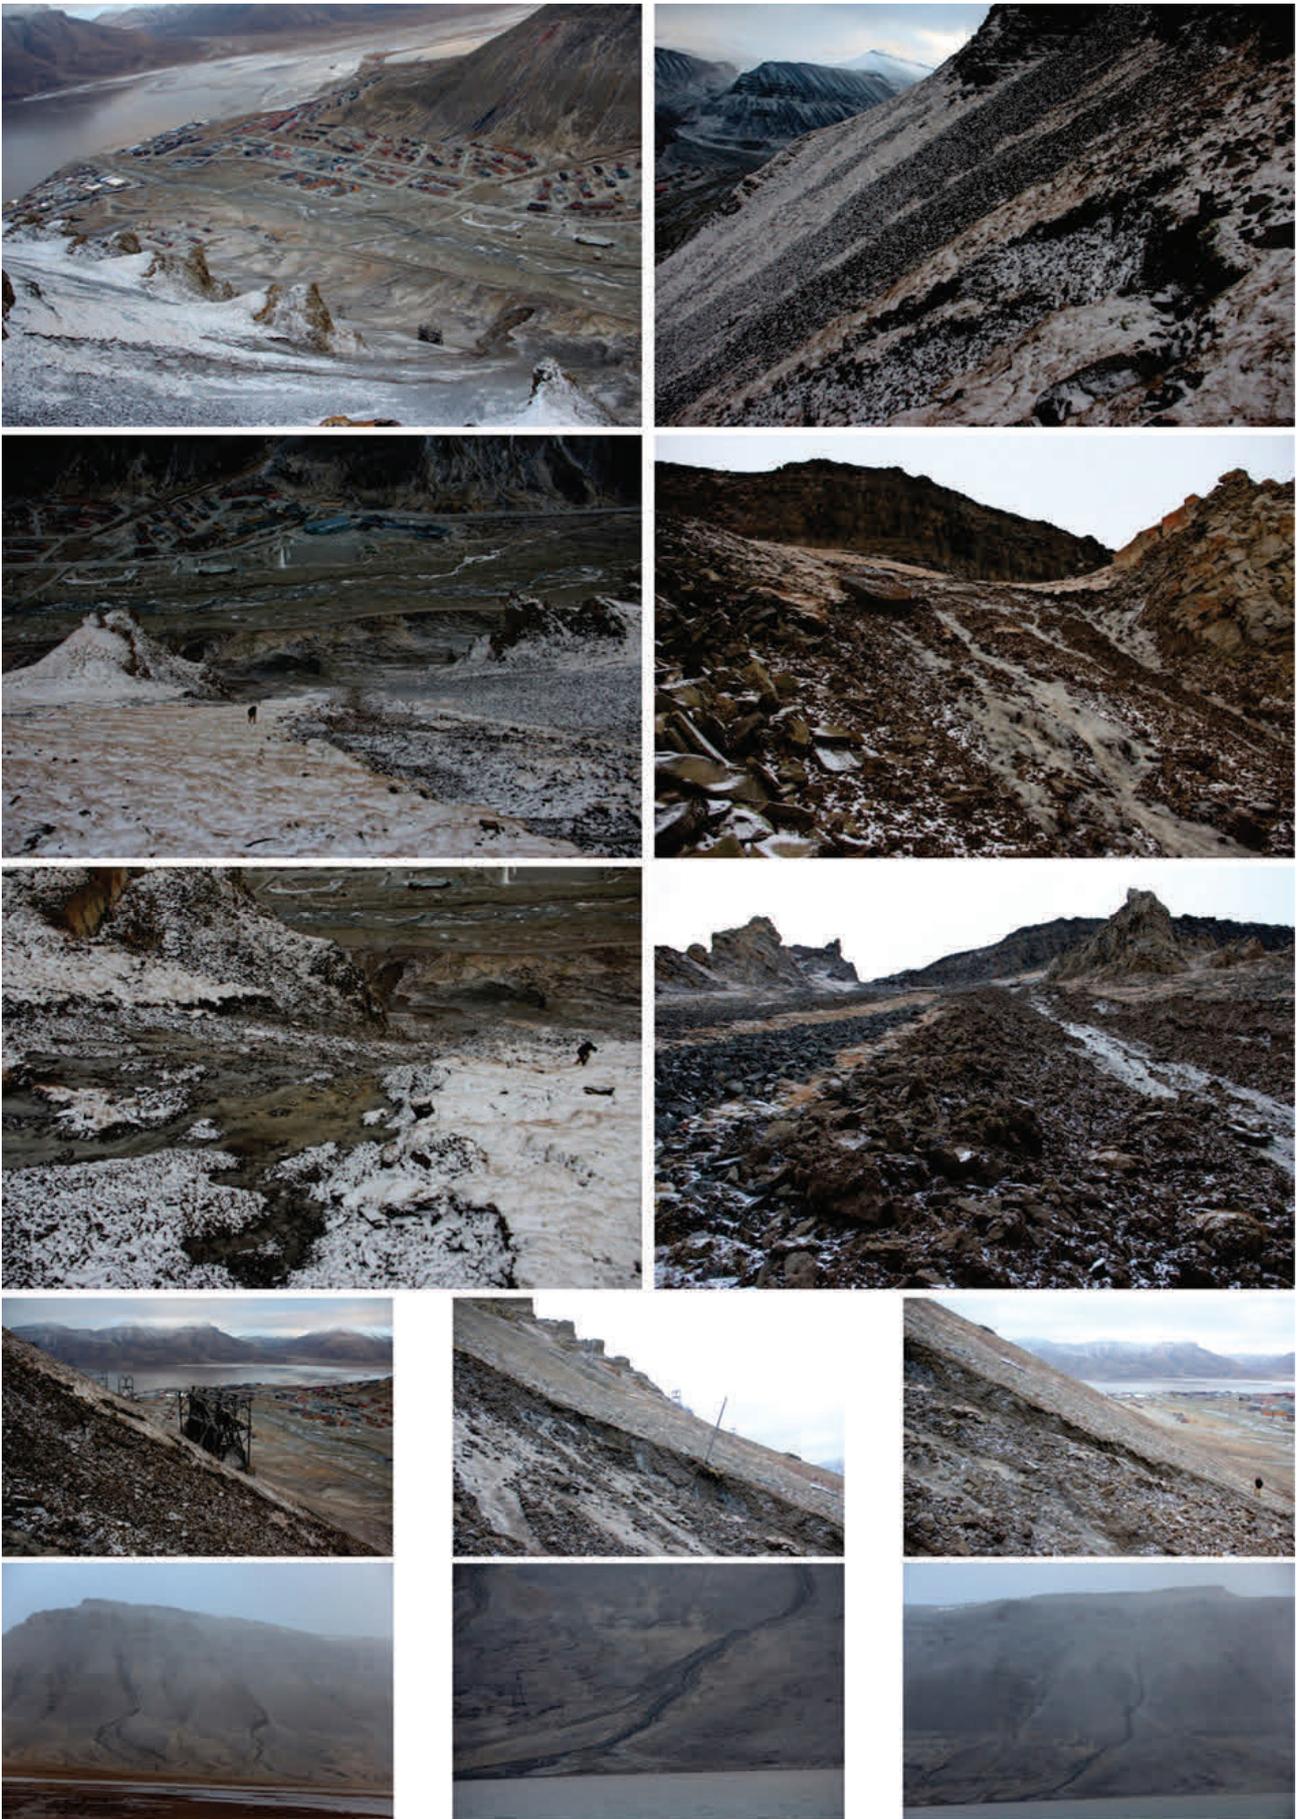
Figure 7. Details of the release area of the Longyeardalen valley cemetery slide and flow area. Lower 3 photos are from the debris flows in Adventdalen at the eastern end of Isdammen. Photos: Wesley Farnsworth, 16 October 2016.

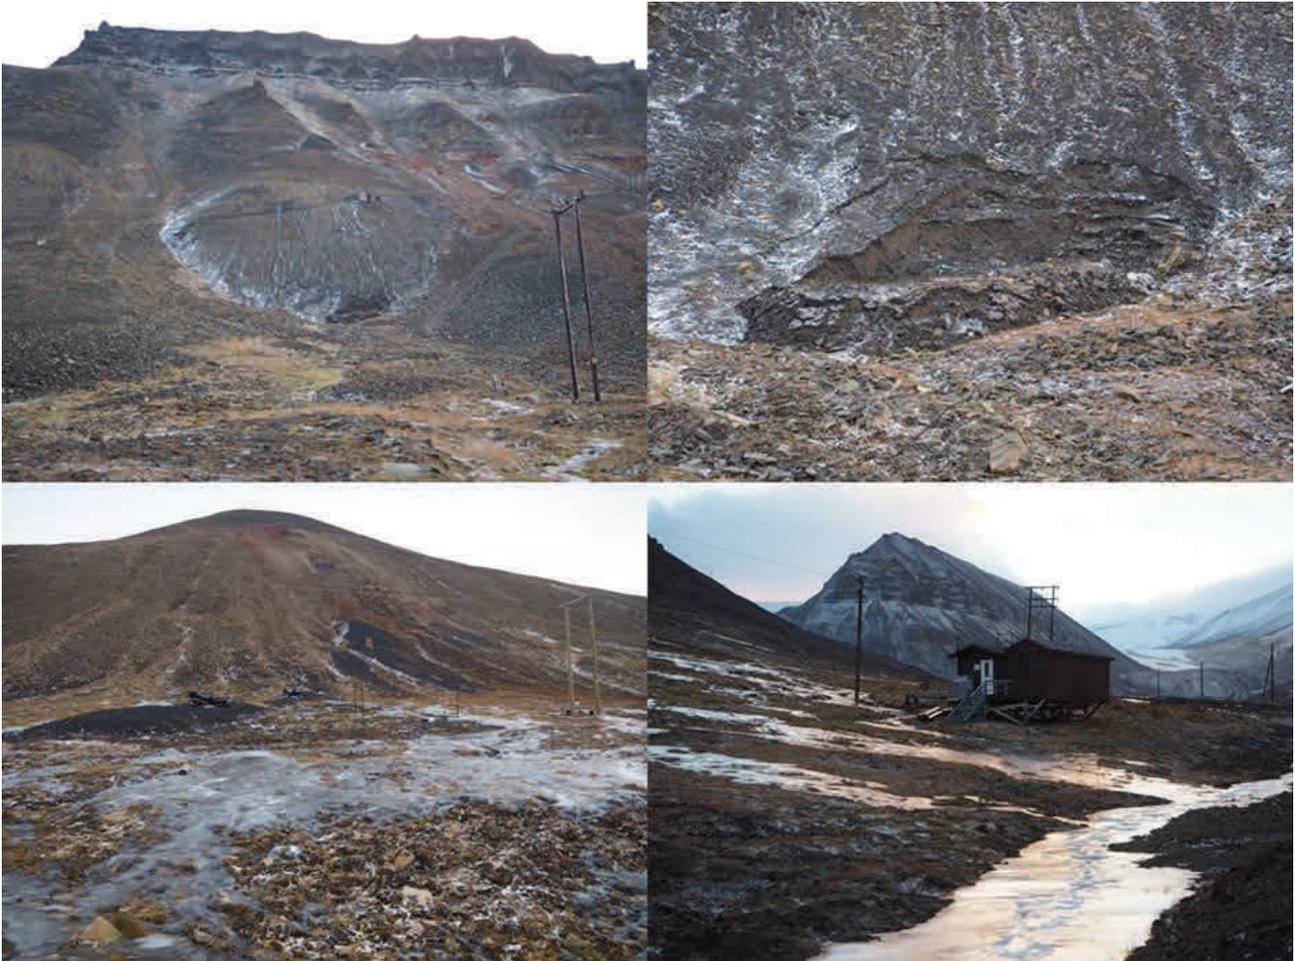
Figure 8. Overview (upper left) and detail (upper right) of slump in the upper Longyeardalen valley (opposite to the school). Frozen overland flows in the lower valley sides in both lower (lower left) and middle (lower right) Longyeardalen. Photos: Hanne H. Christiansen, 16 October 2016.

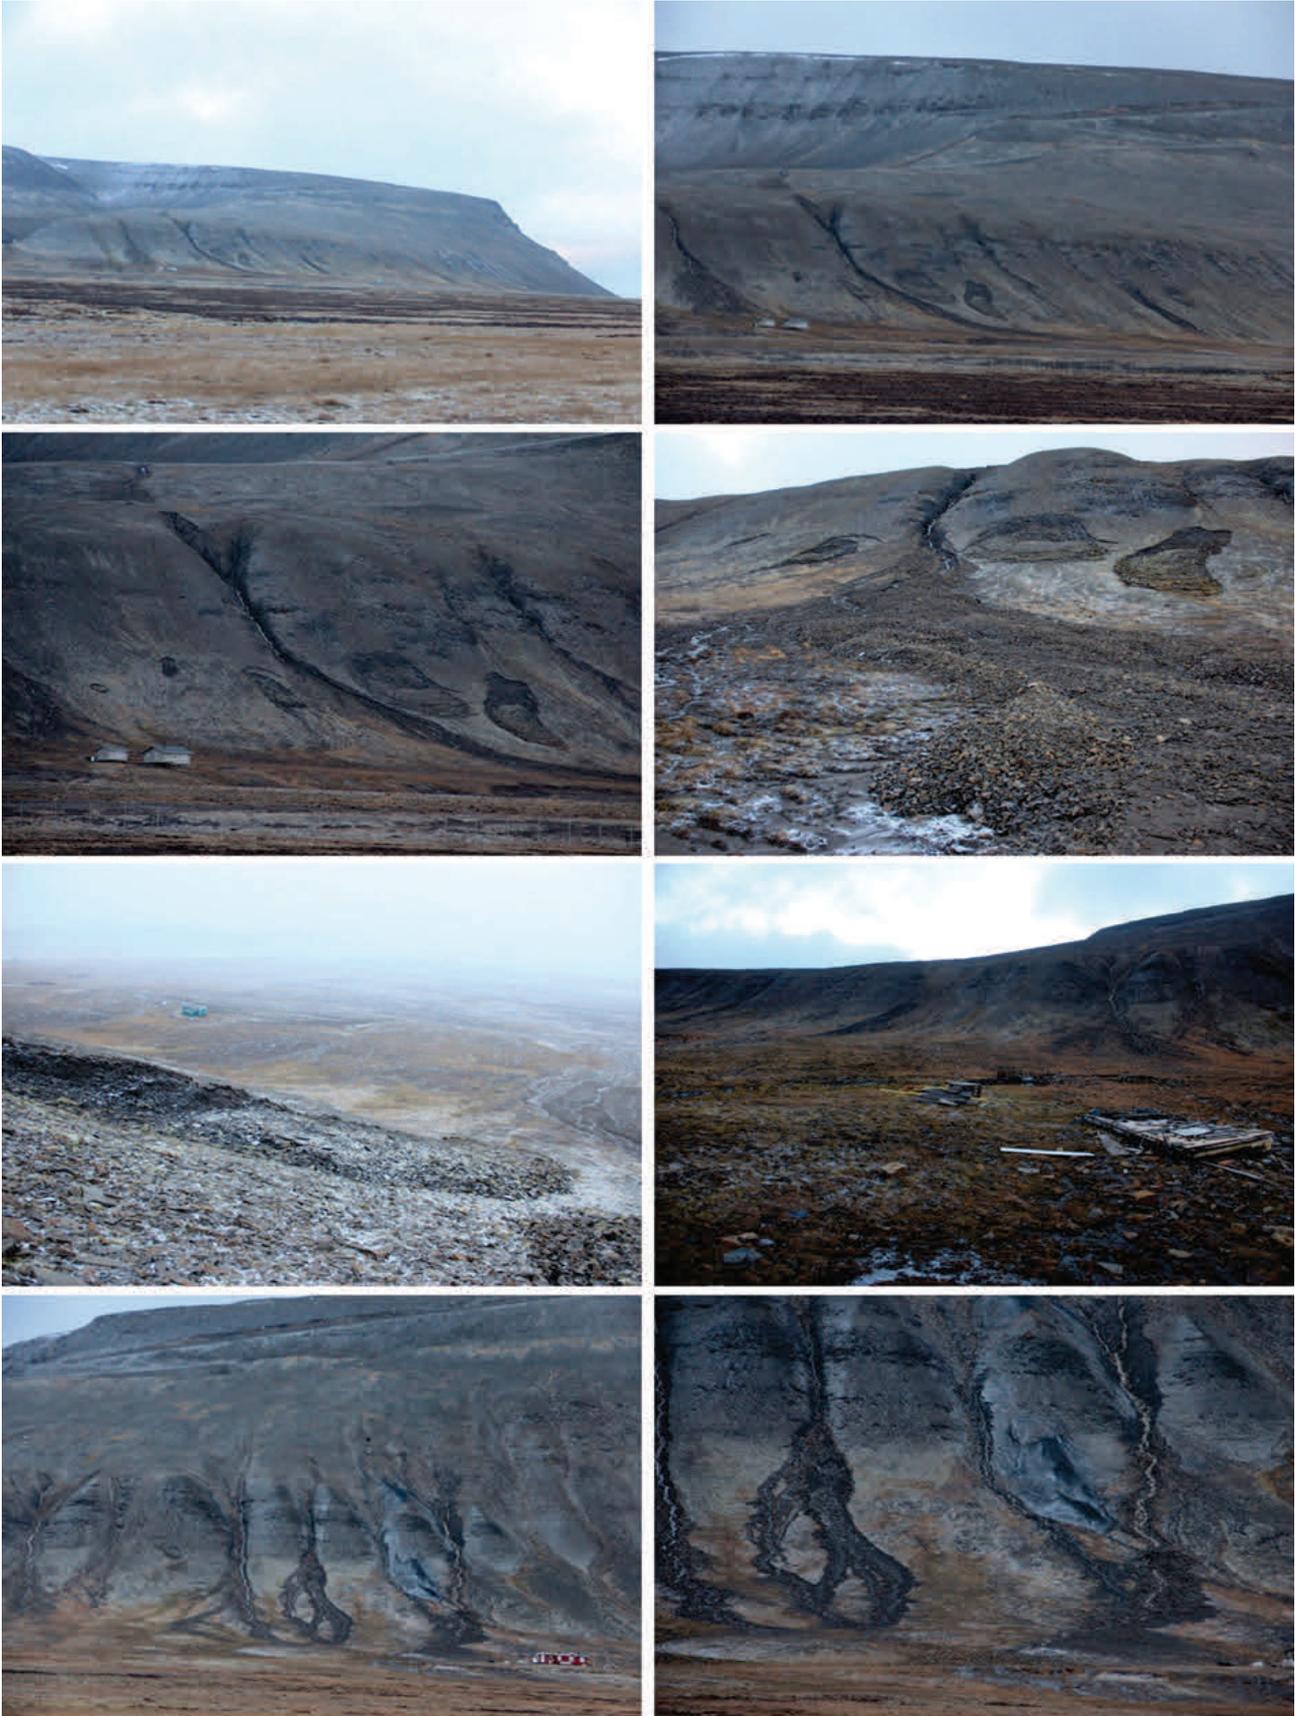
Figure 9. Overview and details of active-layer detachment slides and debris flows from the area below the Svalsat road next to the airport. Photos: Wesley Farnsworth, 15 October 2016.

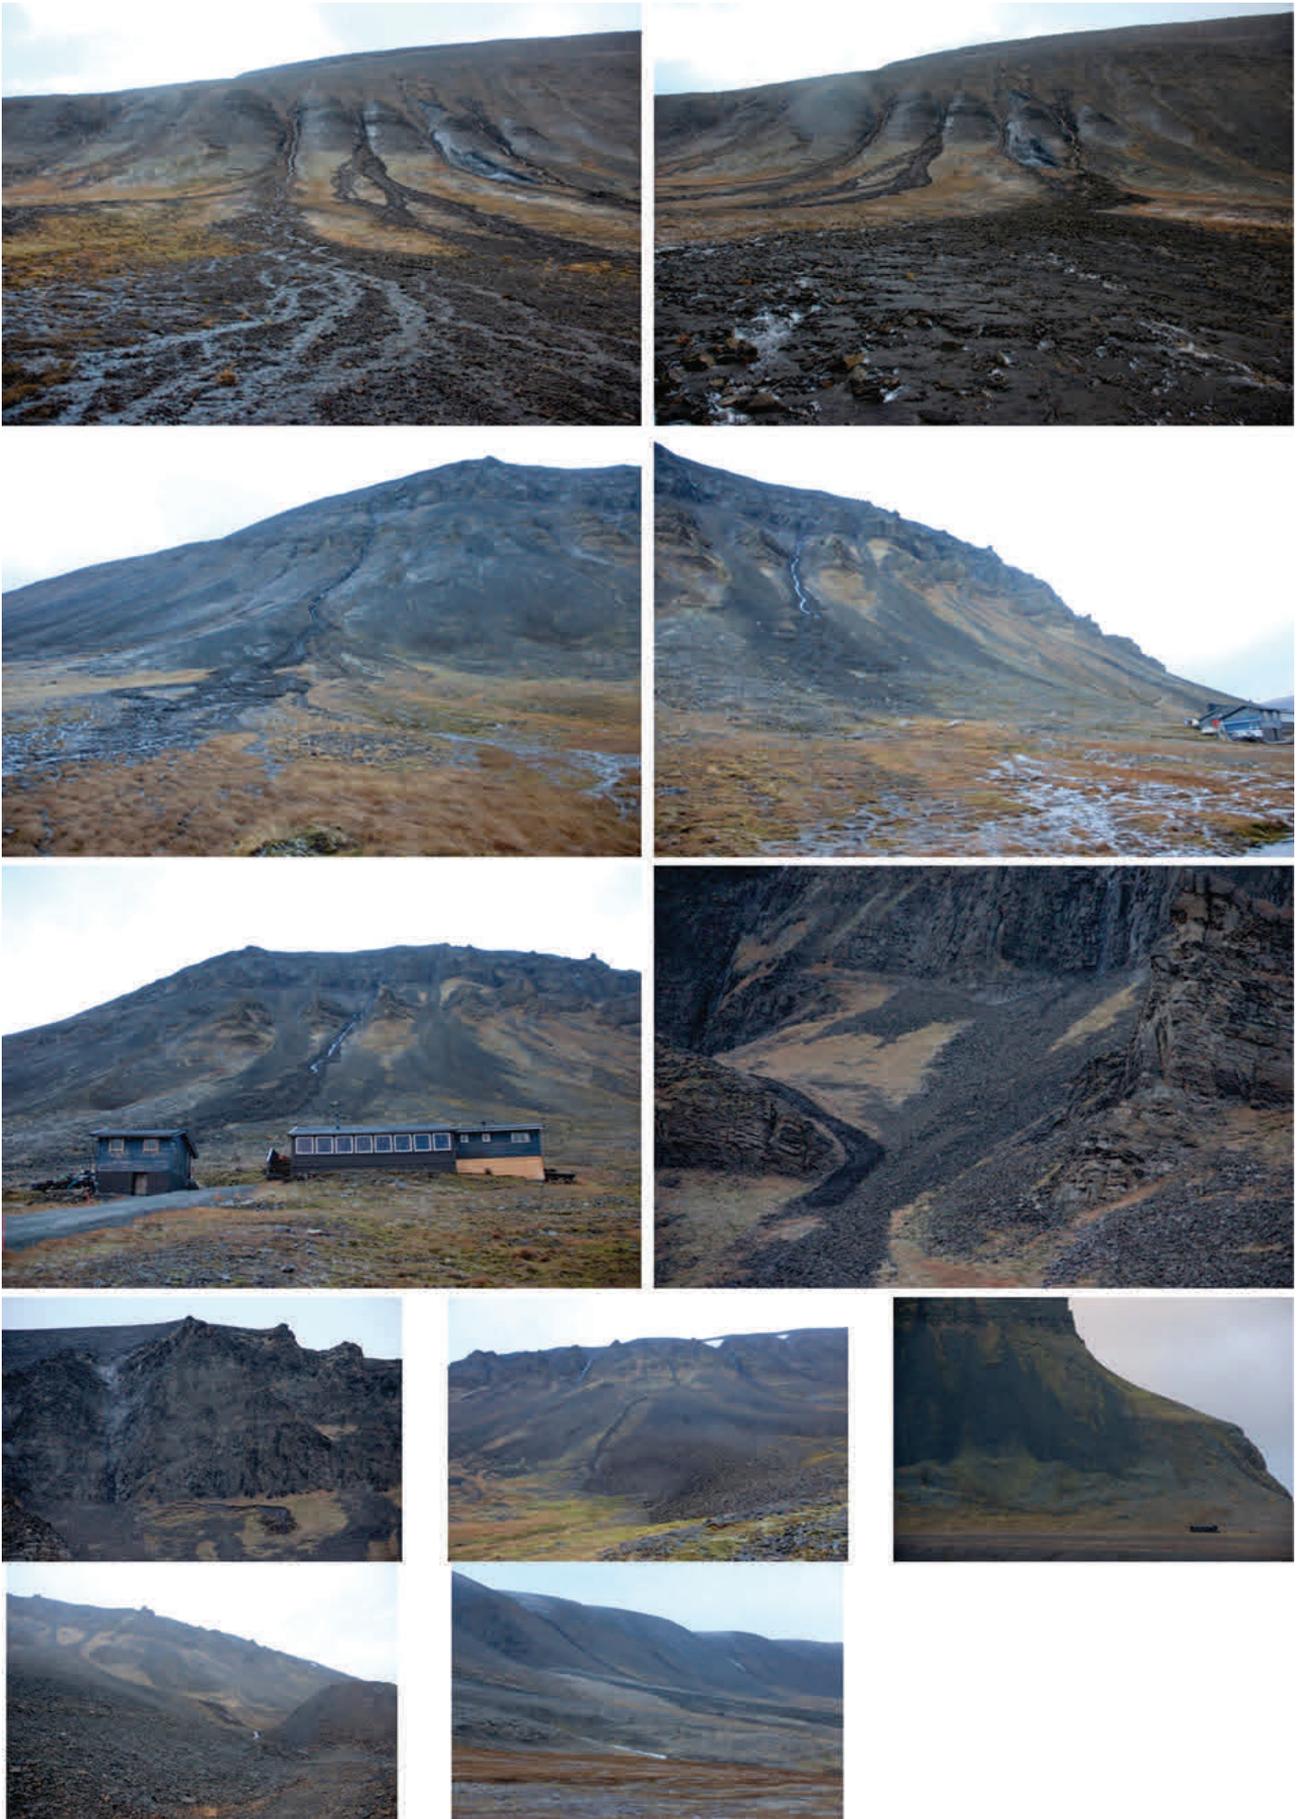
Figure 10. Debris flow further along the road towards and in Bjørndalen. Photos: Wesley Farnsworth, 15 October 2016.

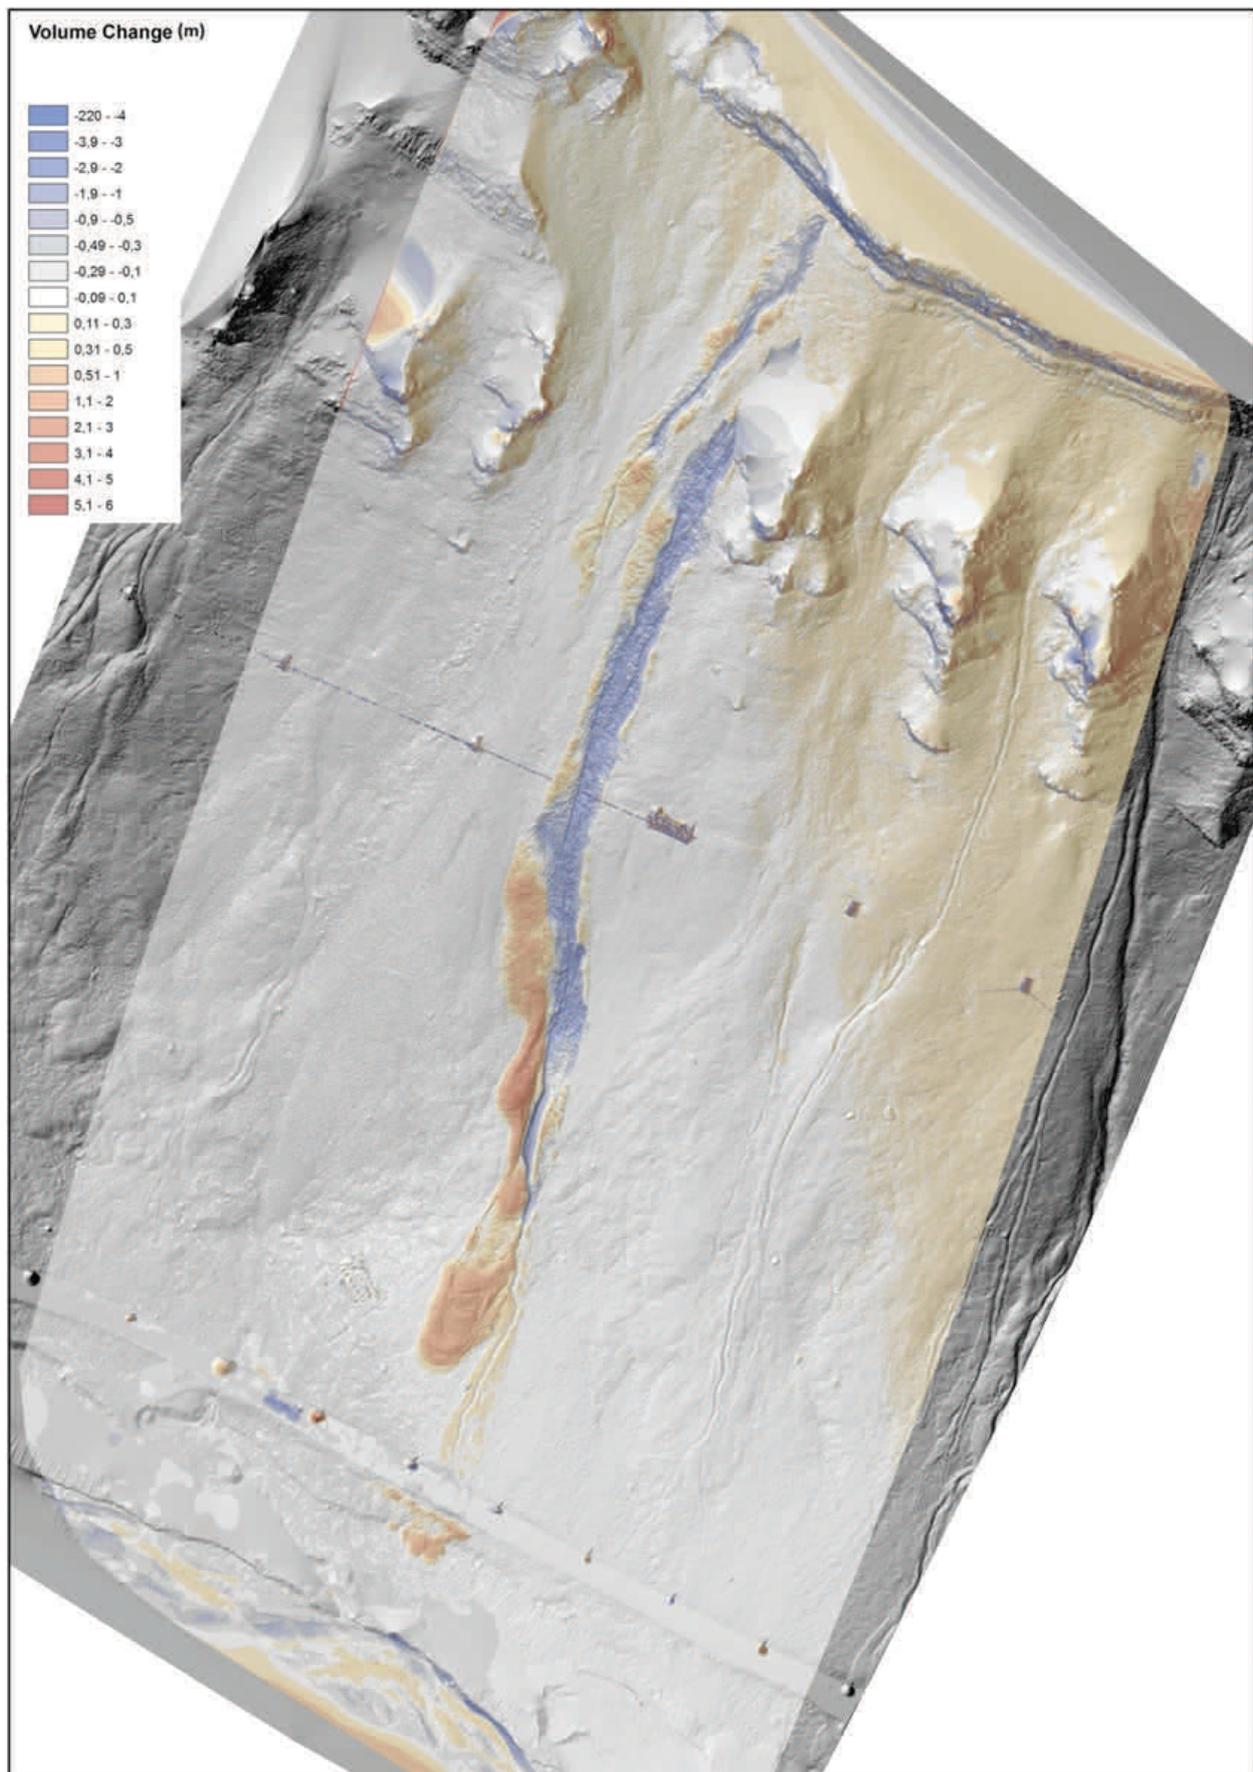
Figure 12. Volume changes of the surface between 16 September and 18 October 2016 in the area of the cemetery slide and flow area. Data obtained by repeated laser scanning. Blue colours showing erosion and red colours showing deposition. The scan was made the day after the debris masses that covered the road were removed, which is why they do not appear.

UNIS uses a high resolution laser scanner for hazard assessment and can survey all surface changes near Longyearbyen, such as snow avalanches, rock fall, and other mass movements. Change detection of the largest active-layer detachment and debris flow event at the cemetery was completed using a laser scan of the area from 16 September 2016 (before event scan) and from 18 October 2016 (after the event scan) with a resolution of the surface models of 10 cm. With this method, the two surfaces can be compared and an accurate determination of the volume change can be calculated (Figure 12). In total, an area of 23000 m² was covered by the debris flow, and a volume of 5000 m³ of material was displaced. It is possible to identify both the eroded areas in the release zone and the depositional areas below the slide path (Figure 12). The deposits of this slide and flow are up to 5 m thick, and the associated eroded areas are up to 2-3 m deep (Figure 12).

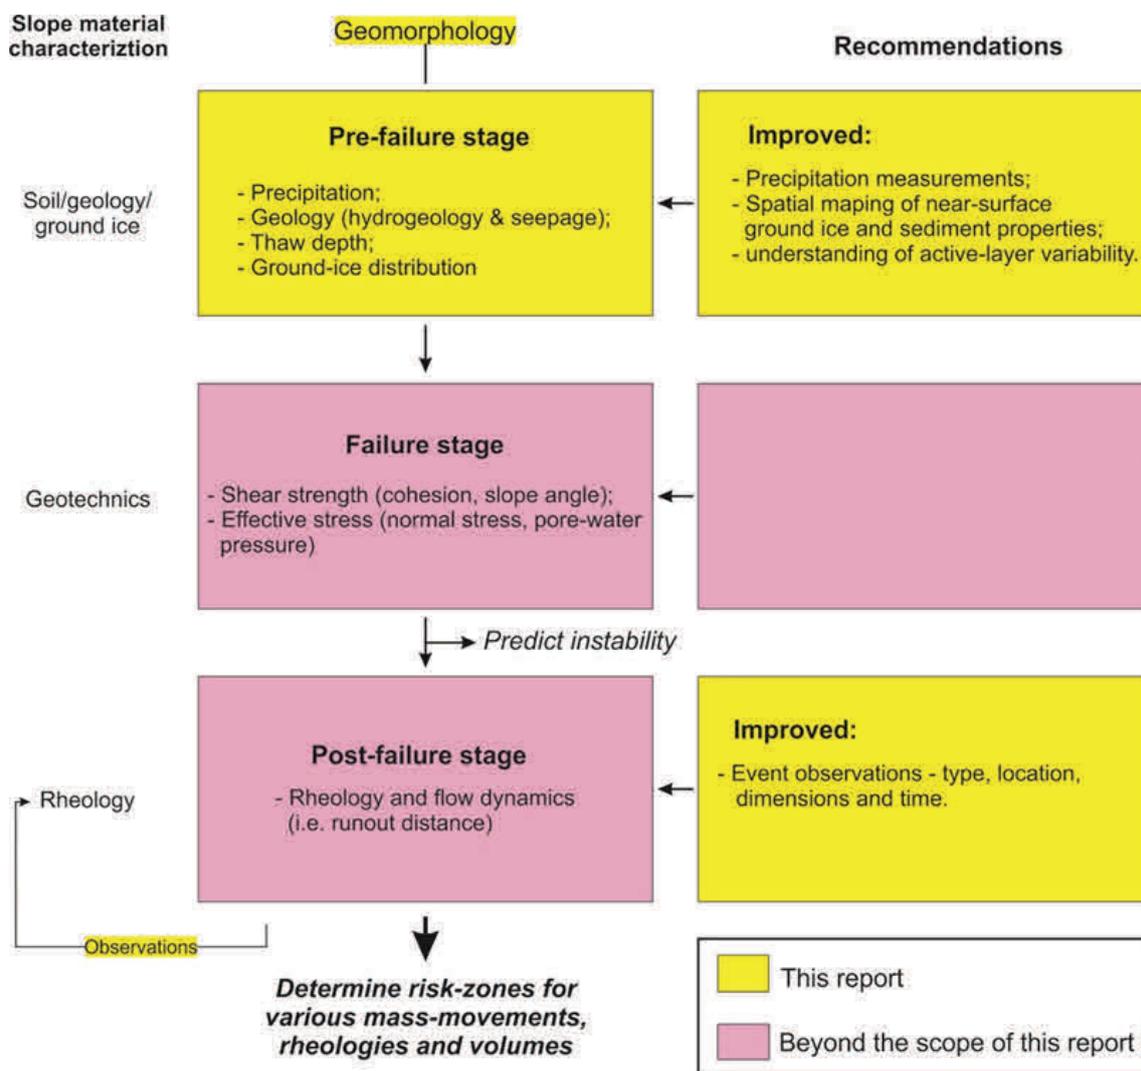
Figure A. Defining the contributing factors in the slope-failure continuum. Three-stage event subdivision modified from Malet et al. (2005).

The temporal subdivision of slope failure into three discrete categories provides a starting point from which to study the factors contributing to slope instability and the impacts of mass wasting on Arctic slopes (Figure A). During the *pre-failure* conditioning of a slope, meteorological, geological and geocryological factors – primarily precipitation (rate and magnitude), sediment properties, ground ice content and thaw depth – are of primary importance. These variables contribute to the slope-stability thresholds during the *failure stage* due to the influence of soil moisture and sediment properties on pore-water pressure and the shear stress along potential failure surfaces. Shear strength, the intrinsic resistance of the slope-material to failure, additionally varies as a function of slope steepness and cohesion, at a soil-particle level. Slope failure is initiated once shear stress exceeds shear strength. During the *post-failure stage*, the area impacted by the mass movement varies due to rheological properties of the earthflow material, the release volume and the flow mechanics (Malet et al. 2005). Improved knowledge of these factors together with the analysis of observed events can be back fed into models to estimate risk zones for different mass-movement types with different rheologies and release volumes.
