## Impact of changing climate on infrastructure in Longyearbyen: stability of foundations on slope terrain – case study

Field and Laboratory Report 2018 – Geotechnical Investigations

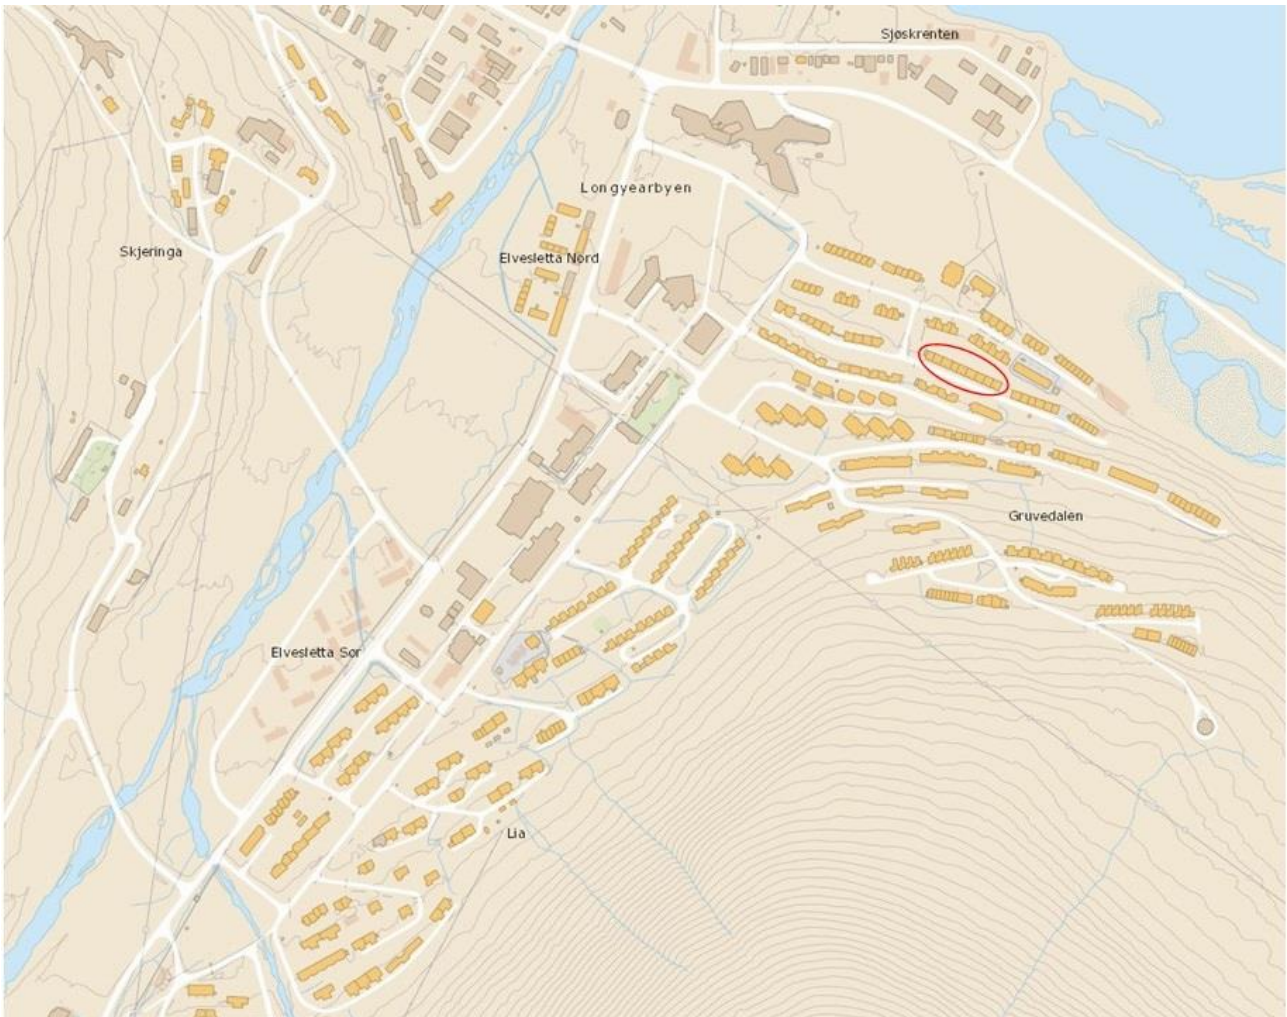
**Figure 2. Location of the site in Longyearbyen ([6]).**

The drilling campaign took place at Svalbard in Longyearbyen (see Figure 1). The location of the soil investigation was at the building No.33 in road 236 as shown in Figure 2. Approximate location of the two boreholes made during fieldwork is shown in Figure 3.

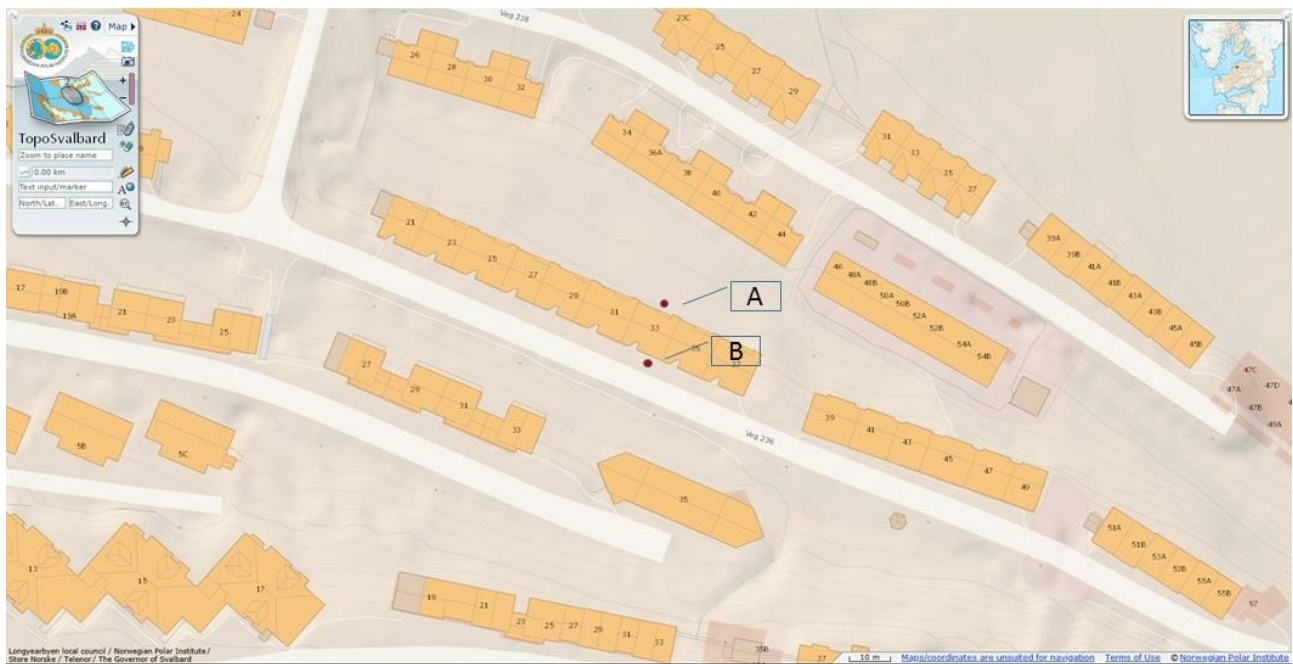
**Figure 3. Approximate location of boreholes at the building No.33 in road 236 ([6]).**

Two boreholes have been drilled at the site of field investigations (see Figure 3), and the coordinates for the boreholes based on measurements with hand-held GPS are presented in Table 1.

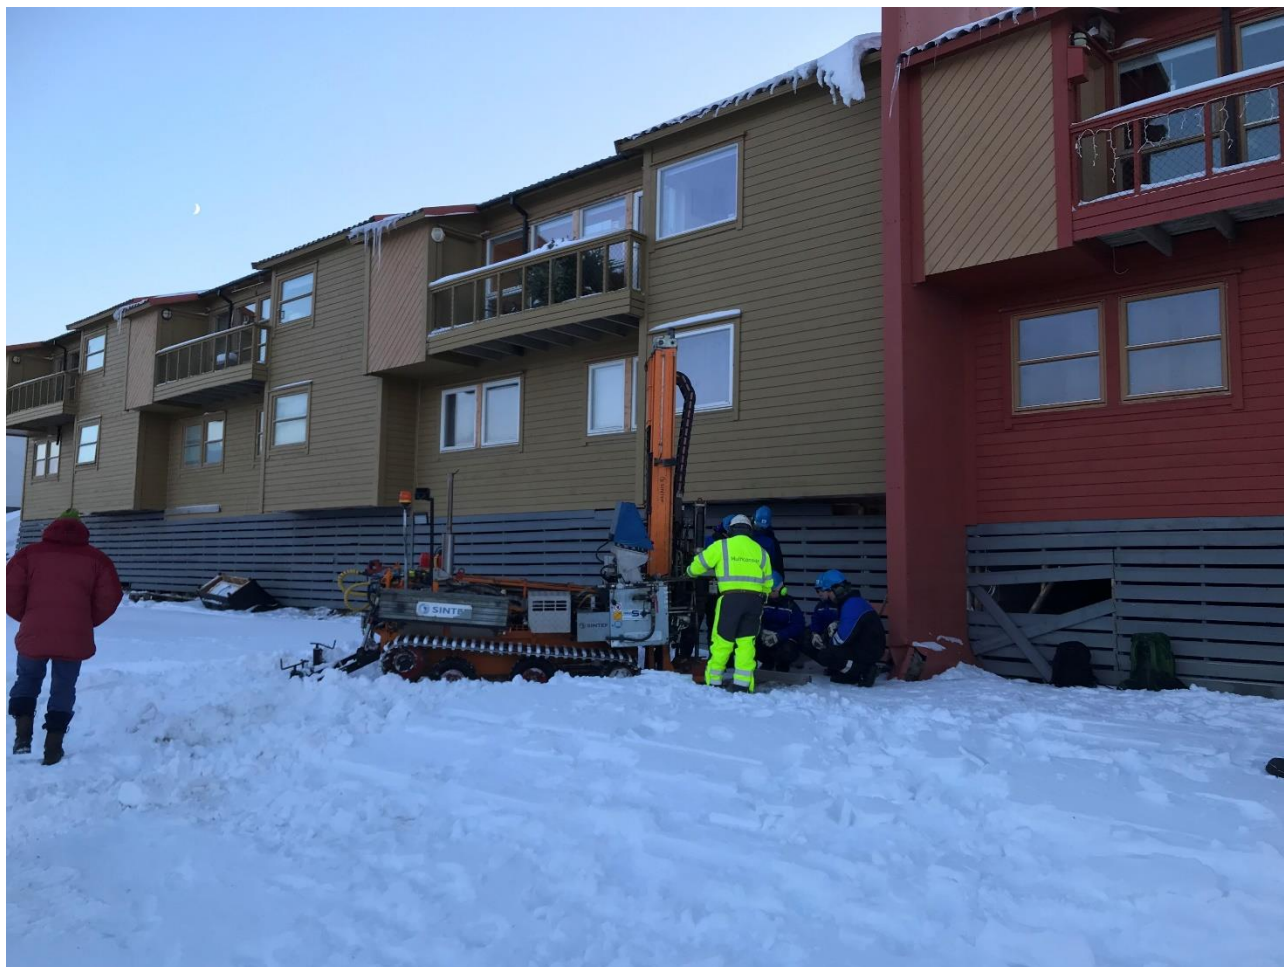
Fieldwork is performed with SINTEF's custom built Geotech 504 drilling rig. The drilling rig can be disassembled to make it easy to transport in parts with helicopter if necessary. The drilling rig is equipped for different types of drilling and sounding, cone penetration testing, permafrost coring and conventional piston sampling. The drilling rig in operation at the building No.33 in road 236 is shown in Figure 4.

**Figure 4. Fieldwork at the building No.33 in road 236.**

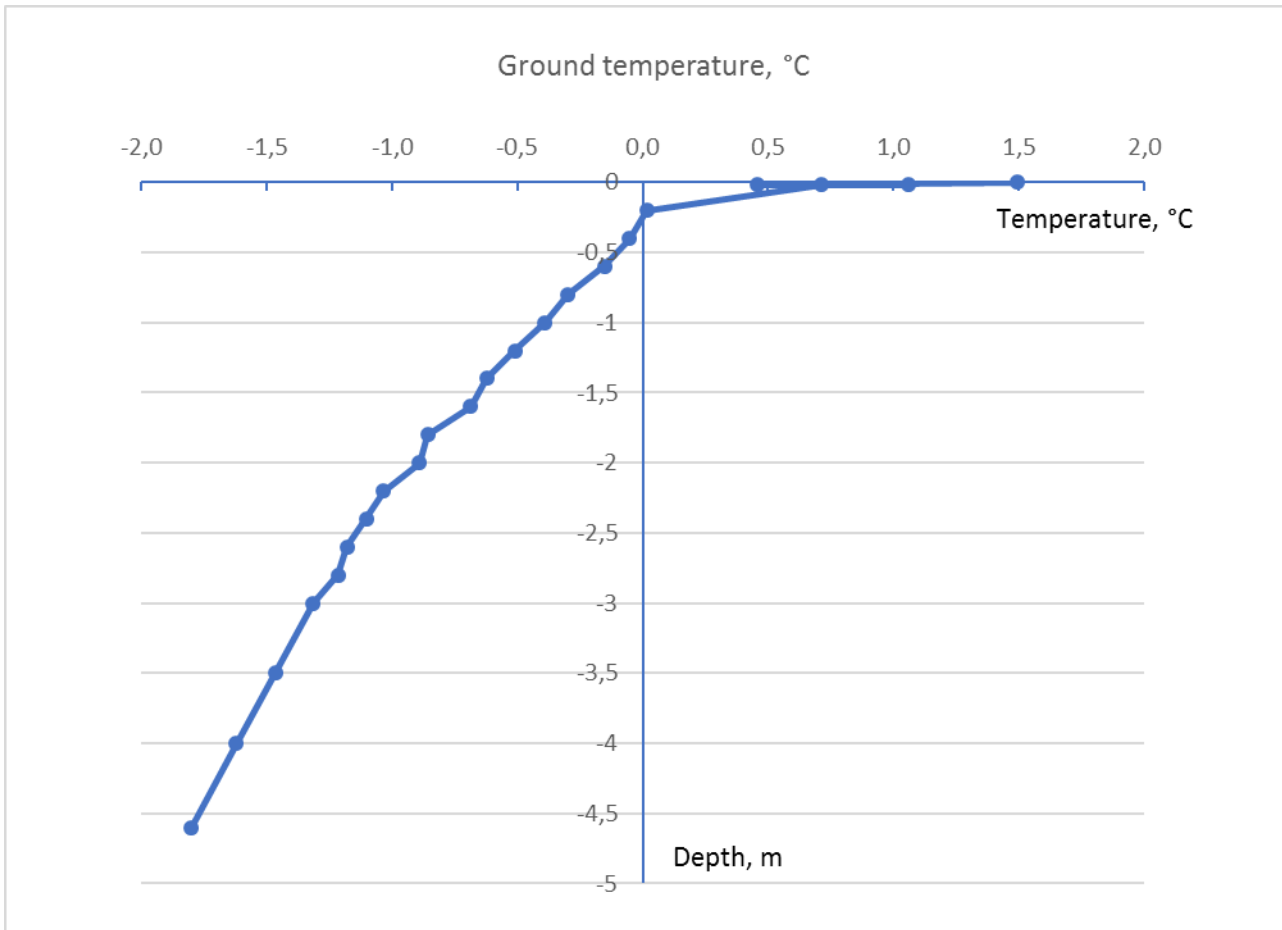
The calibrated thermistor string was installed in a 50mm diameter plastic casing in Borehole A on October 21<sup>nd</sup> 2018. Reading of temperature from the thermistor string in the "air-filled" casing was performed on

October 22<sup>nd</sup> 2018 (see Table 4), and is shown in Figure 5. Ground temperature at the depth -4.5 m was recorded as -1.8 °C.

**Figure 5. Ground temperatures in Borehole A on Oct 22<sup>nd</sup> 2018.**
