Isdammen report 2009

AT- 205

Frozen Ground Engineering for Arctic Infrastructure

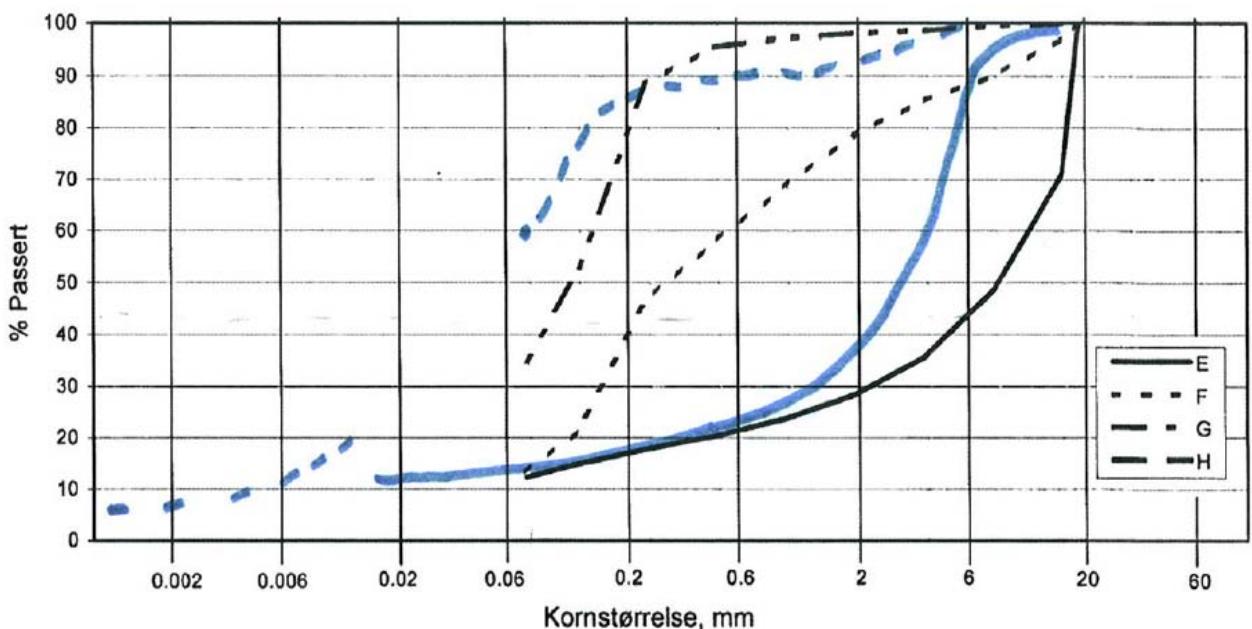
Comparison of grain size data with respect to depth gives an impression of a remarkable difference in grain size from September 2008 to February 2009. It seems like the grain size at one depth in 2009 fits well with the grain size at a couple of meters deeper in 2008. In a geological perspective, such a short time period rejects this impression. In Figure 8 the black lines illustrates the grain size curves from 2008 while the blue ones illustrate the distribution curves from 2009. The solid drawn curves show the top layer distribution, while the blue dotted curve should correspond to the two different black dotted curves which illustrate deeper layers. Because the drilling in 2008 went deeper than in 2009 it is suspected that curve F should correspond best to the blue dotted line. As the Figure illustrates, the solid drawn curves corresponds well. The 2009 curve is moved a little to the right for the 2008 curve, as expected due to the difference in the grain size data. The similar shape of the curves indicates constant variances in grain size, which implies that the difference came during the drilling process. This dissimilarity was predicted in the lab report from AT205 spring 2009 at page 16, because of an observation of crushed material.

This comparison gives the impression that the grain size is smaller in 2009 than it was in 2008. As mentioned, this difference may have occurred because of crushing of material during drilling. It may also partly be caused by the sharing of lab work among several inexperienced students.

Figure 8: Grain size distribution, [1]

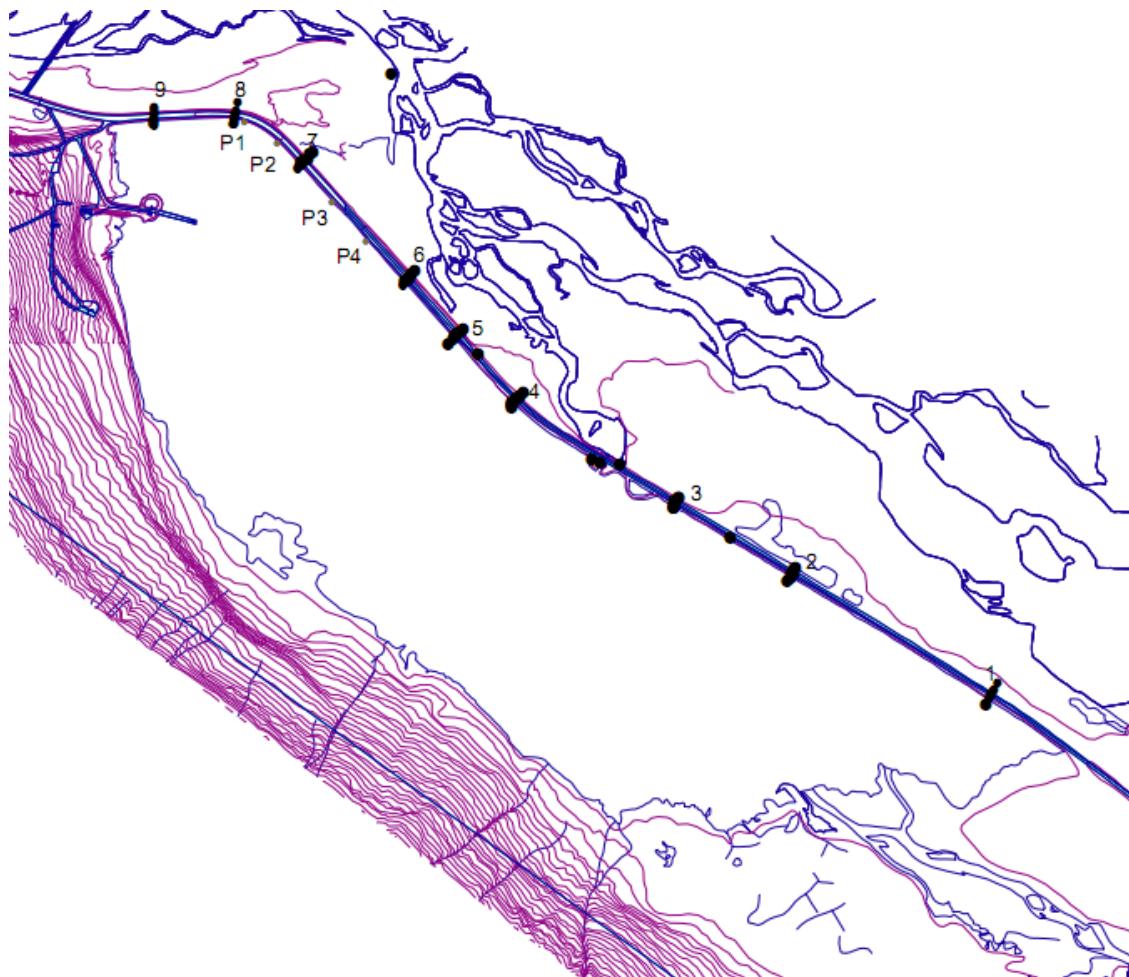
NGI (Norwegian Geotechnical Institute) has done field investigations along the 2.5 km road embankment enclosing Isdammen in 1979 and 2008 (Figure 10).

Figure 10: Road embankment enclosing Isdammen water supply for Longyearbyen. Cross sections P1-P4, May 1979, and 1-9, September 2008 [1]

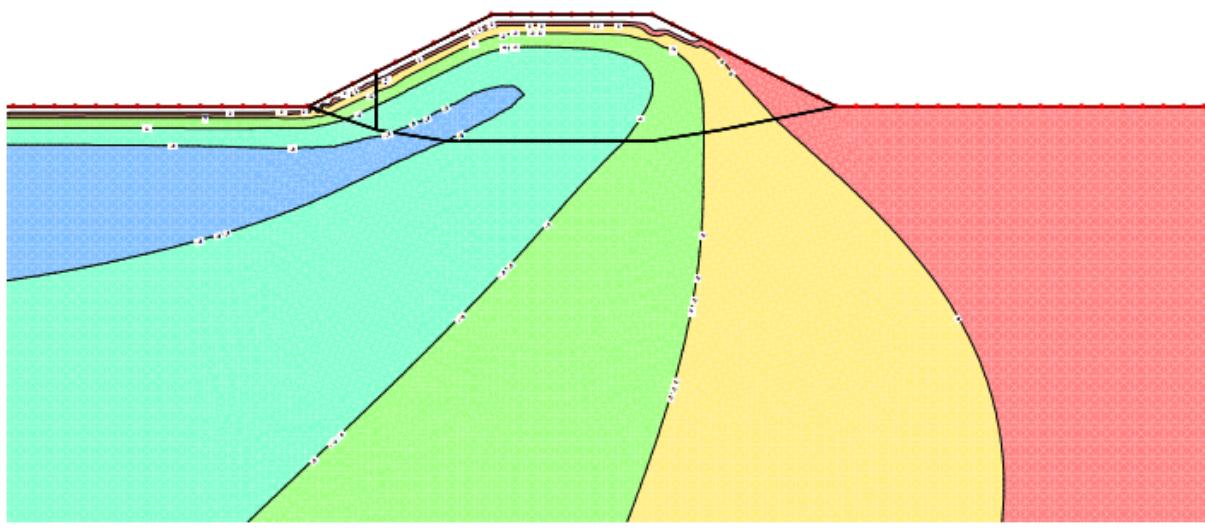
As shown in Figure 14 the top layering of the road embankment has thawed in the autumn, but there is still a considerable frost wedge in the lower part of the downstream shoulder. This presumably stops any major leaks during this time of year.

Figure 14: Early autumn. 0-isotherm is between red and yellow. Temperature intervals are  $2^{\circ}\text{C}$  [1]

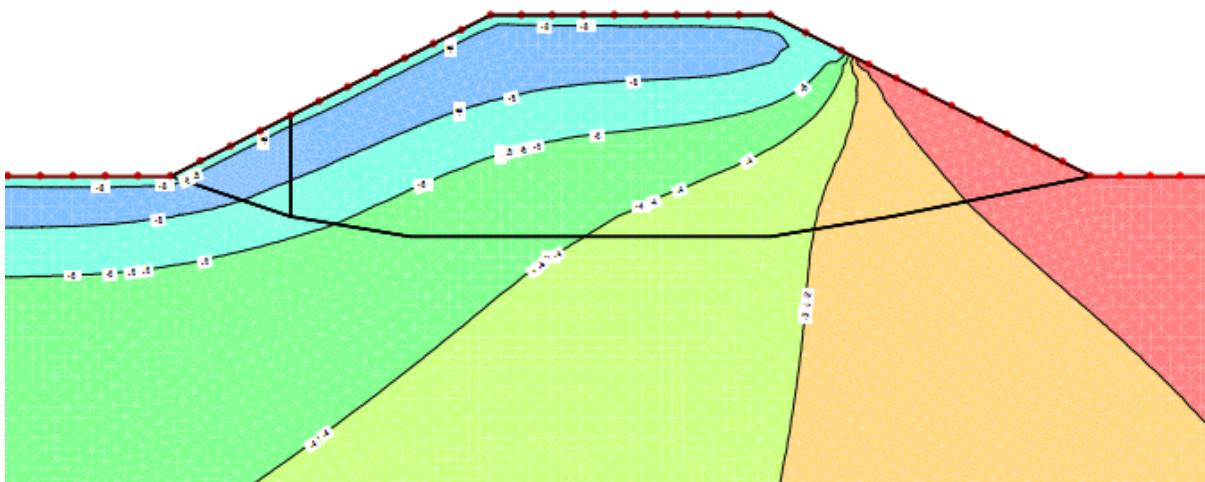
Figure 15 shows the same profile during spring where the embankment is more or less frozen, forcing the 0-isotherm far out on the upstream shoulder.

Figure 15: Spring. 0-isotherm is between red and yellow. Temperature intervals are  $2^{\circ}\text{C}$ . (Annual mean air temperature increased by  $+2^{\circ}\text{C}$  from  $-6.7^{\circ}\text{C}$  to  $-4.7^{\circ}\text{C}$ ) [1]

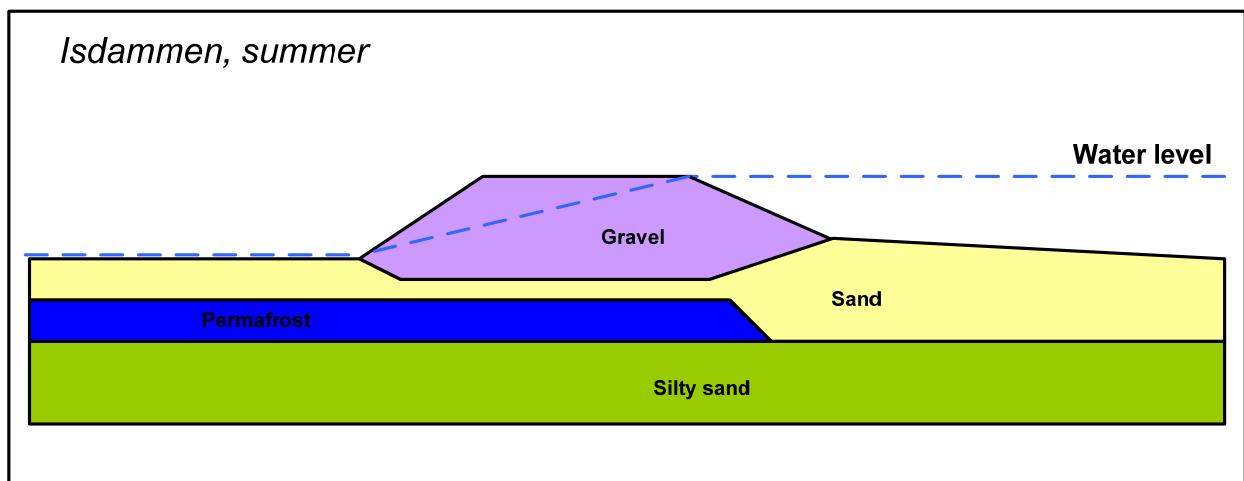
**Figure 16: Model of Isdammen dam during summer**

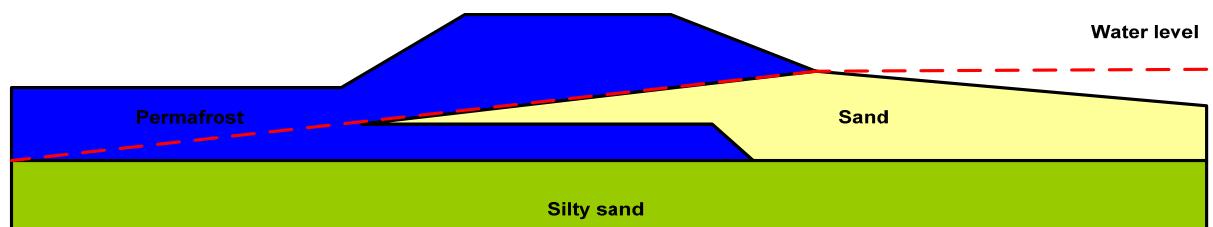
Also winter and summer states were taken into account. The water level and condition of the soils are different depend on the season. During winter most of the soils are frozen. There is a small area under the road which is unfrozen due to heat fluxes from the lake. In the field investigations we've found this area with unfrozen water. Also the water level in Isdammen is decreasing because of freezing.

**Figure 17: Model of Isdammen dam during winter time**
